Manufactured-Stone Nightmares

by Dennis McCoy

Without proper flashing, heavy-duty building paper, and weep holes, walls behind cast-stone veneer can get wet

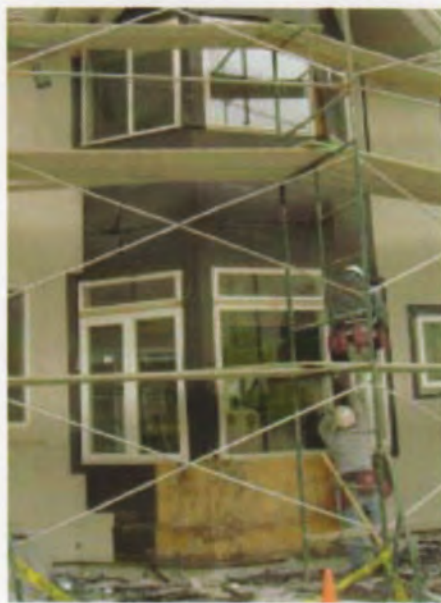
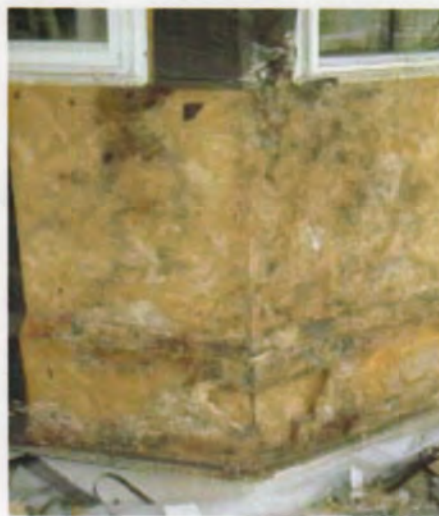
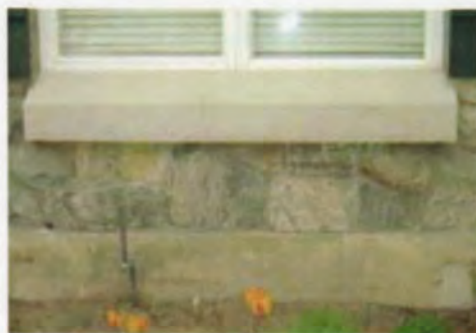
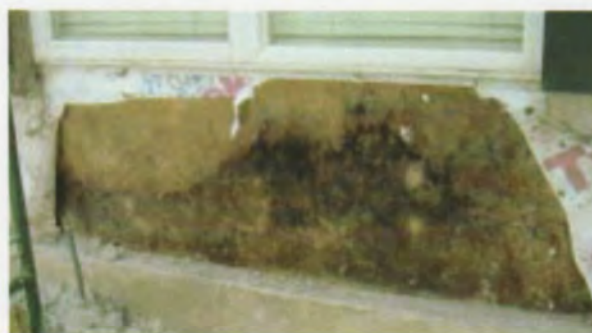
leaks and rot often show up sooner, progress more quickly, and cause more severe damage inside the wall (see Figure 1).

Figure 1. Where stucco (top photos) and cast stone (bottom) have been installed on the same home, the author frequently finds more severe moisture and rot damage under the cast-stone portions of the exterior. One reason is that the stucco terminates at the bottom with a weep screed, while the cast stone sits in a bed of mortar and grout, directly on a foundation ledge, with no weeps or flashings.

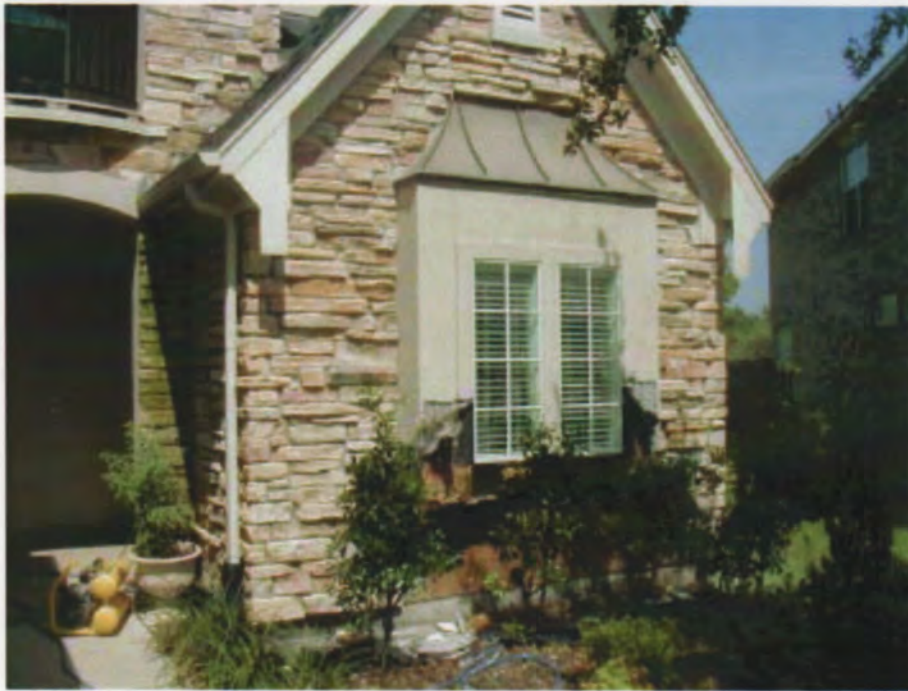
For one thing, manufactured stone is a cement-based product that absorbs and holds water like stucco, but cast stone is thicker than stucco and can thus store more moisture. Also, most of the cast-stone brands now have "ledge-stone" versions of the product, which have a long, horizontal shape; the long, flat, shelflike ledges are often sloped toward the framing when installed, which provides a place for rain water

to puddle up and soak into the wall (Figure 2, next page).

Figure 2. Long, flat “ledgestone” pieces like this create many horizontal shelves where water can stand and soak into grout joints.

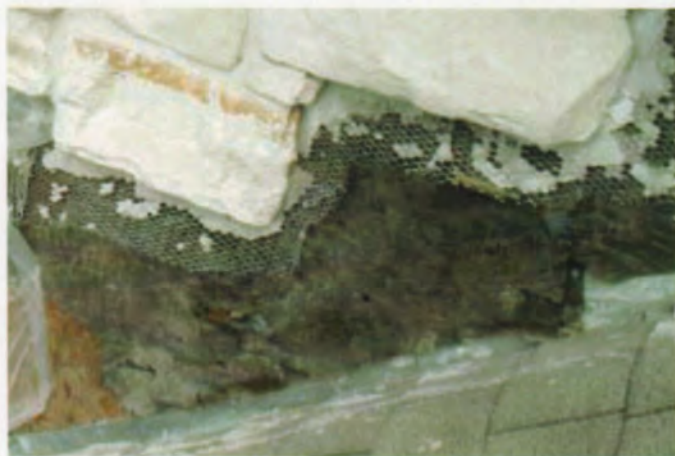
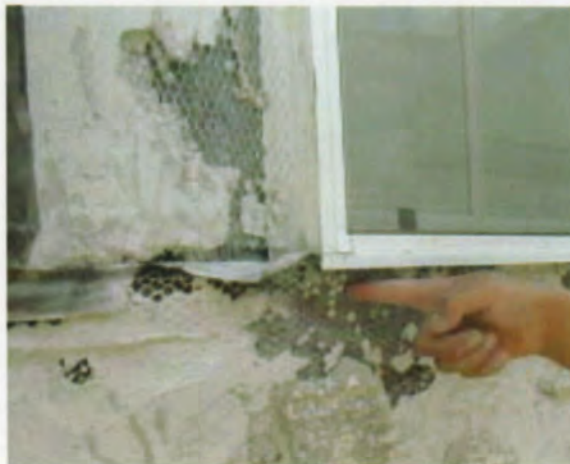
The greater thickness of cast stone also complicates the task of fabricating and installing practical flashing components. The kickout or diverter flashing required where a roofline butts into a wall is a good example. On job after job, my company gets paid good money to go in after the fact, tear cast-stone veneer off a wall, and retrofit a larger kickout flashing to the wall because the original roofer's kickout flashing was too small to push water out beyond the plane of the cladding. If the diverter flashing is too small, it may as well not be there: All the water flowing and blowing against that spot will just get dumped into the wall system below (Figure 3, next page).

Figure 3. Undersized or omitted diverter — or kickout — flashings allow water to flow beneath the cast-stone facade (above). Window flanges that lap under instead of over building paper can bring rain water into direct contact with the sheathing (right).

idea in a manufactured-stone job. However, we are more likely to see a reverse-lap flashing error, with building paper run to the window edge in such a way that the window flange directs water beneath the paper instead of on top of it (Figure 3). And, as with stucco, brick, or any other cladding, a cast-stone veneer should be equipped with weeps of some kind at any bottom termination, whether at the foundation sill or above a window or abutting roof. Otherwise, water will pool longest at the lowest points, and those areas may stay continuously wet.

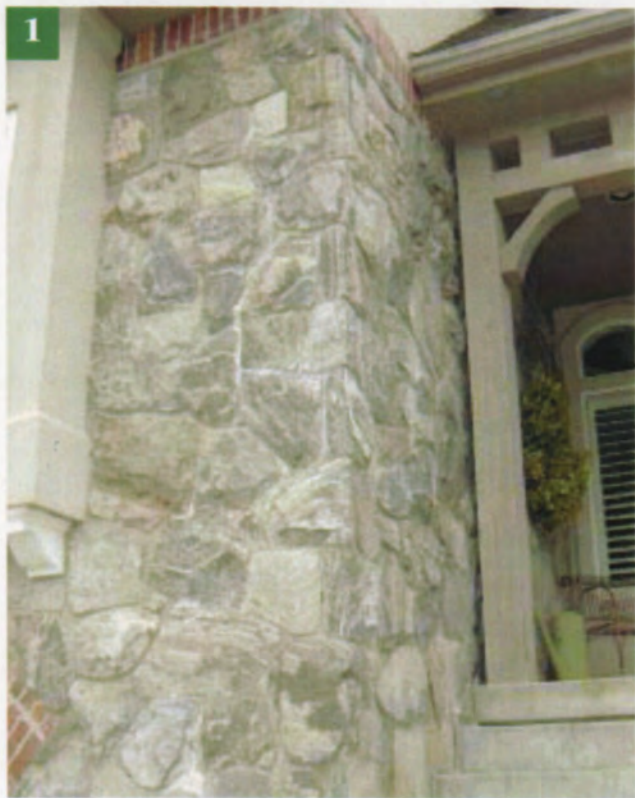
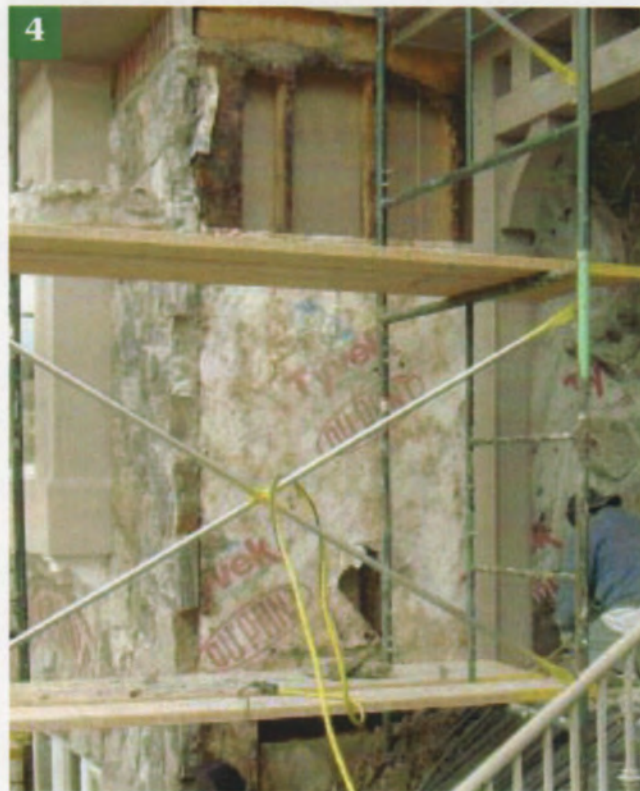
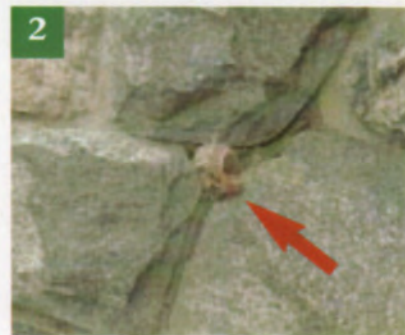
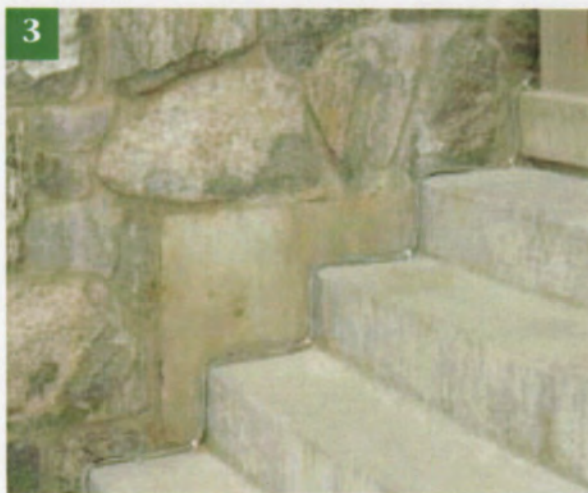
The owners of this one-year-old custom home **1** reported moldy smells behind the drywall; a mushroom growing from the cast-stone veneer face was the only visible sign of trouble on the exterior **2**. The gutter butting into the top of the wall seemed a likely source of moisture, while the bottom of the wall provided no way for moisture to escape **3**.

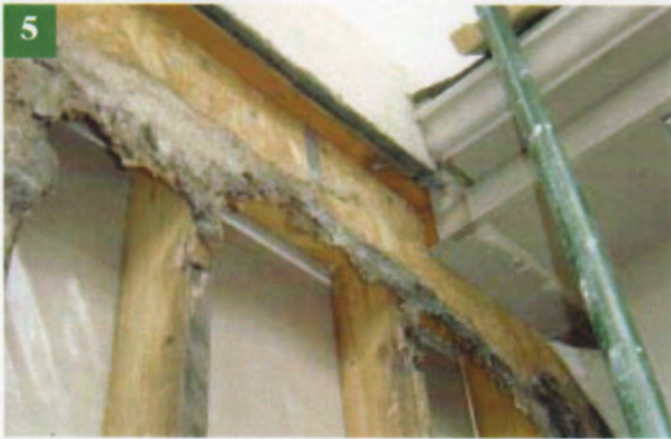
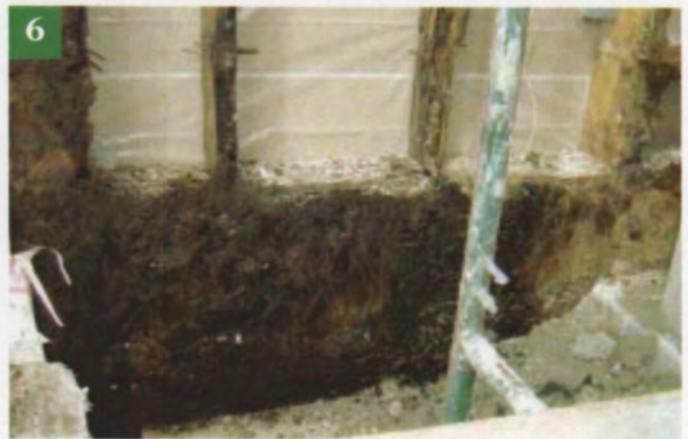
Opening the wall **4** revealed severely rotted OSB sheathing and damage to the framing. While the row of soldier bricks at fascia height provided some protection **5**, the water coming off the roof saturated the cast stone and soaked through the housewrap beneath, turning the sheathing at the base of the wall to compost in less than two years **6**.

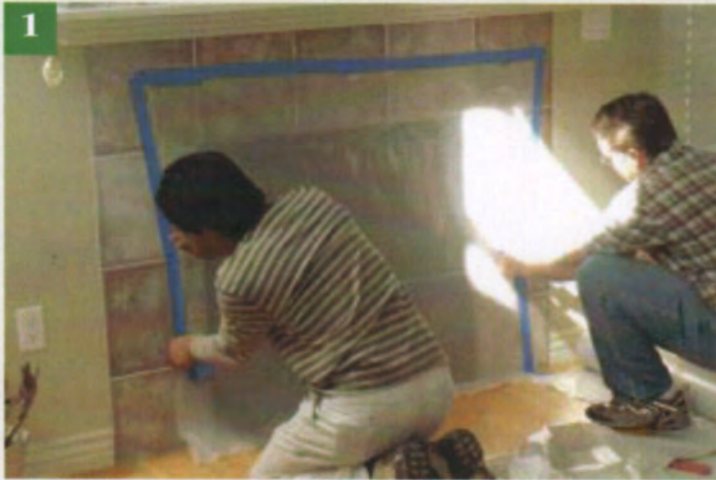
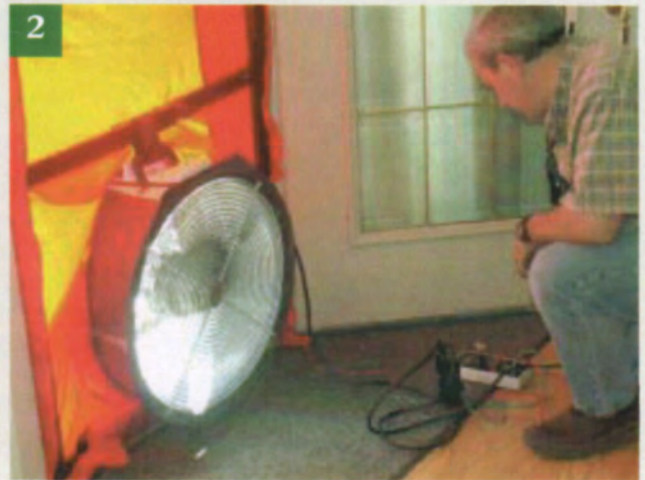
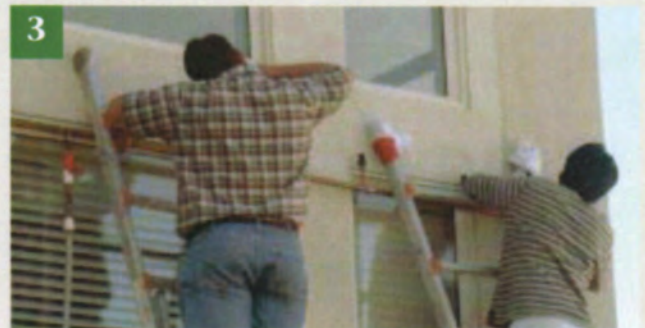
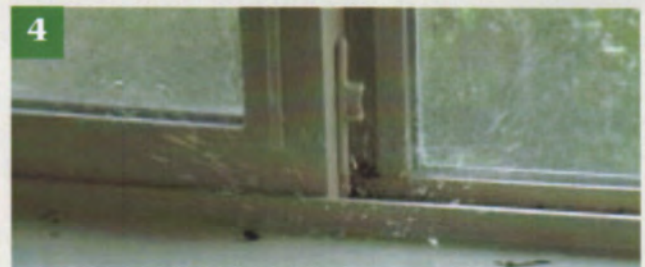
On this job, the original installer of the cast-stone veneer wall had tried unsuccessfully to stop leaks by spraying a clear sealer onto the stone and by removing the lowest courses to apply a membrane flashing where the wall meets the foundation. To assess the problem, the Ram Builders team first seals large openings inside the home **1** and sets up a blower door **2**. With the blower door running to depressurize the house, the crew turns on a water-spray apparatus **3**, thus simulating the effect of a 15-mph wind-driven rain. Within a short time, water finds its way into the house **4**.

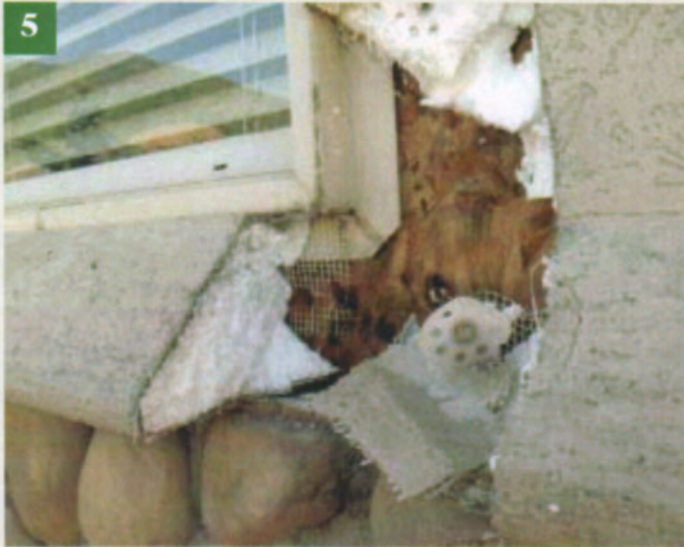
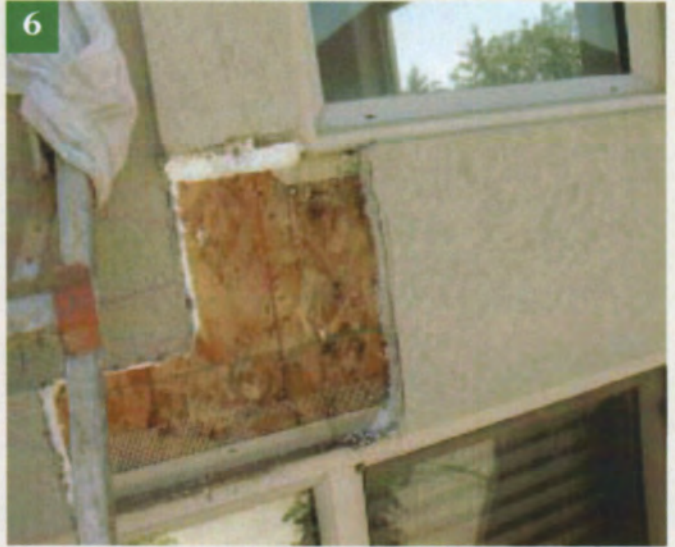
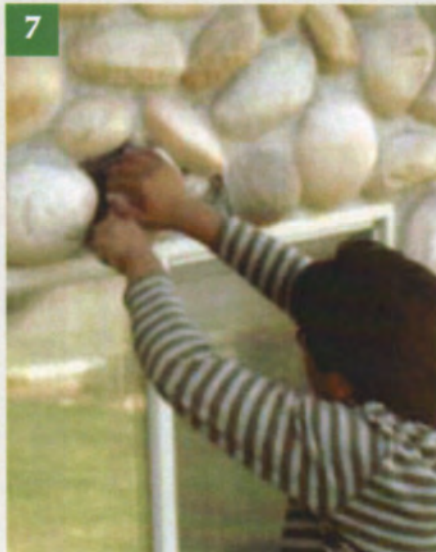
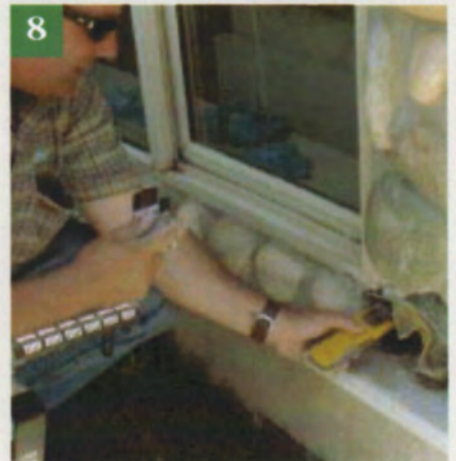
After verifying that the cladding leaks, the team digs under the surface to find out why. Tearing off small areas of EIFS on the upper wall reveals that there is no building paper or window flashing installed where the EIFS meet the cast stone **5**, or between upper and lower windows in the EIFS wall **6**. Tearing off cast stone near a window **7**, the team learns that water has wet the OSB sheathing. The author measures high moisture content even at the bottom of the wall, where no direct stream was applied **8**. The retrofit flashing repair has proven ineffective because flaws higher in the wall dump water behind it.
