CONFIDENTIAL INSPECTION REPORT

Address
Essex County, New Jersey

Requested By:	Client Name
	Client Address
	City, State & Zip
Style of Building:	Single Family
Age of Building:	Age 108+ Years (1910)
Date/Time of Inspection:	April, 2018 / 10:00 AM
Duration of Inspection:	4 Hours & 15 Minutes
Weather:	Rain / Overcast
Client Present:	Yes
Attorney:	Attorney Name
Inspector:	Michael J. McCarthy

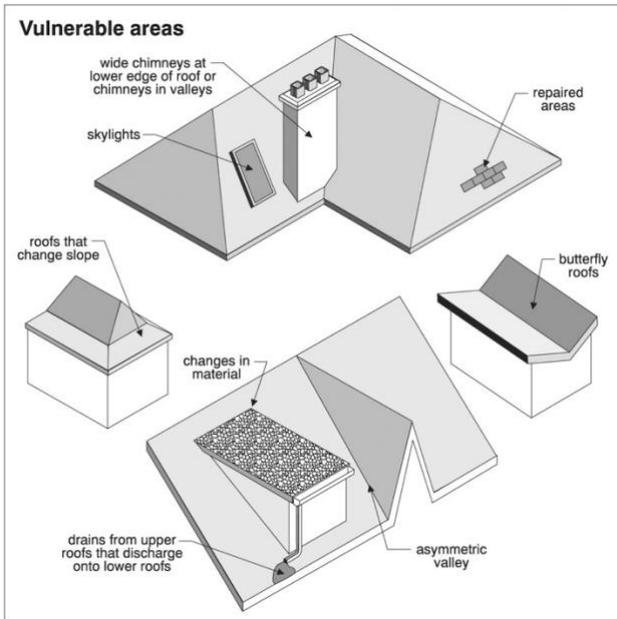
A critical leak area exists on the front right, where the lower roof rake connects to the original house. See photo # 78. For more information about this defect, see the Siding section of this report. A critical leak area is an area where: 1) a pitched roof intersects with a vertical wall of the building; 2) two gable roofs intersect creating a valley; 3) a gable and a sloped roof or a low pitched roof area join. This type of roof area will collect debris, water, snow and ice. It is a high maintenance area and should be well flashed and have ice and water shield installed under the asphalt shingles and 18 inches up any vertical walls. The use of heat tapes may also be necessary to help prevent ice damming and subsequent leaks. It is unknown if any of these leak prevention methods have been installed. Contacting a roofing contractor to further inspect this area by removing some of the shingles and to give cost estimates for any required repairs will be required prior to contract limitations. See illustration below-

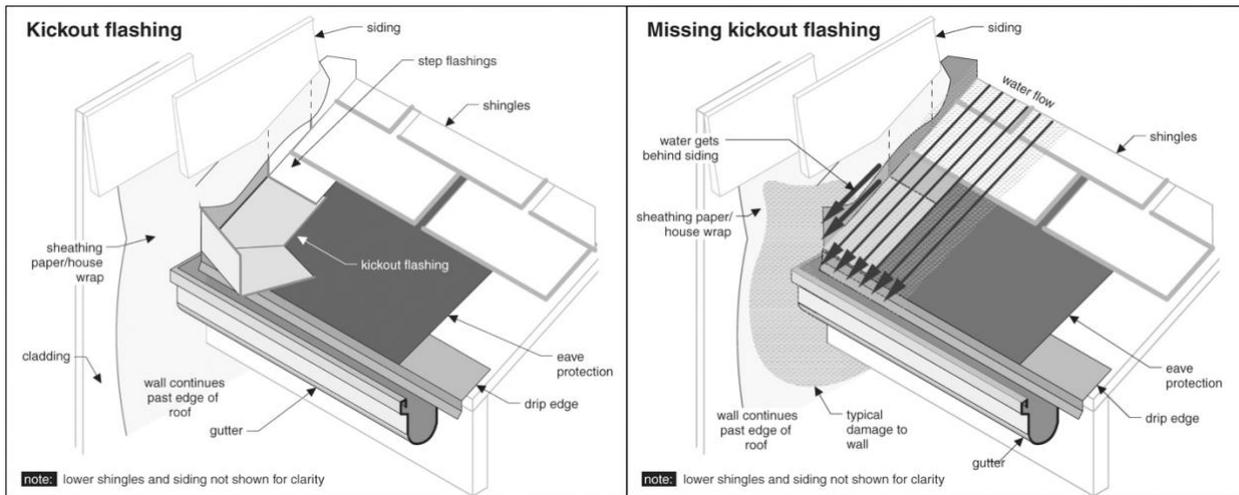
There were no kickout / diverters installed at the bottom of the roof / wall intersection areas which are commonly referred to as side or 'cheek side walls'. See photo #'s 20, 27, 28, 34, 35, 37, 38, 55, 60, 61 & 78. Accumulating roof water runoff should be directed out and away from the building and into the gutters. Roof-to-wall flashing areas should have a kickout / diverter installed at the bottom termination of the side or cheek walls to insure that water is directed away from siding and other wall surfaces. The installation of kickout / diverters will be required to prevent leaks and water damage from occurring. Obtaining cost estimates for their installation is recommended prior to contract limitations. Please refer to Article #'s S1, S19, S24 & R15 on our website at www.NJComprehensiveHomeInspection.com for additional information on this topic. See illustration below-

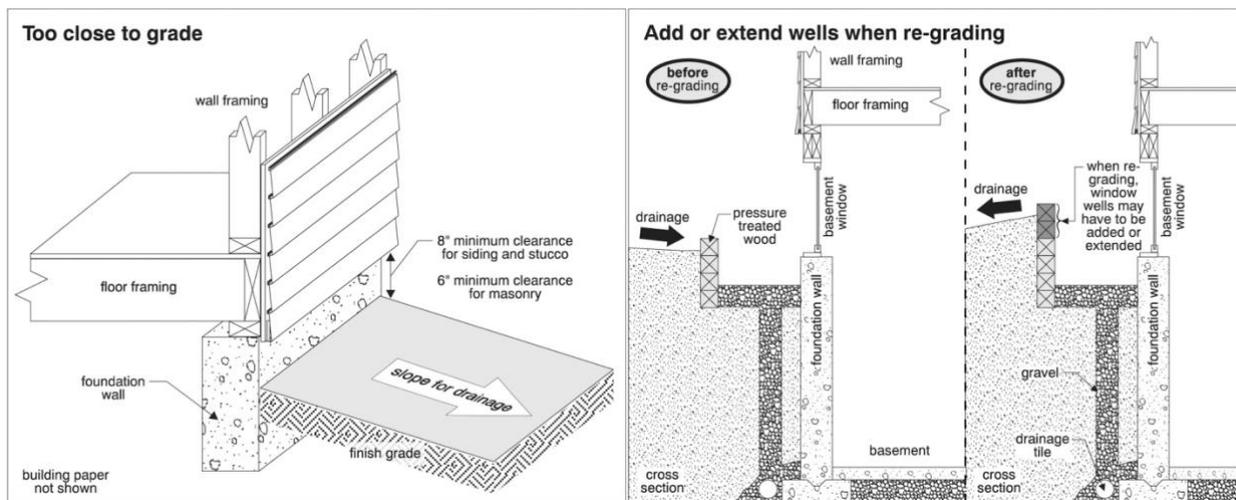
Note : The illustration below is for a window well, but the same type of installation could be used for grading a low foundation wall.

Soil was placed over the siding on the right rear side of the building. See photo # 67. This is a condition conducive to rot, mold and wood destroying insect infestations. Lowering the soil level below the siding material will be required. Treating this area for the prevention of termites is also recommended. Current building standards require an 8-inch clearance from the wood framing to the final soil level. Cost estimates should be obtained prior to contractual limitations. See illustration below-

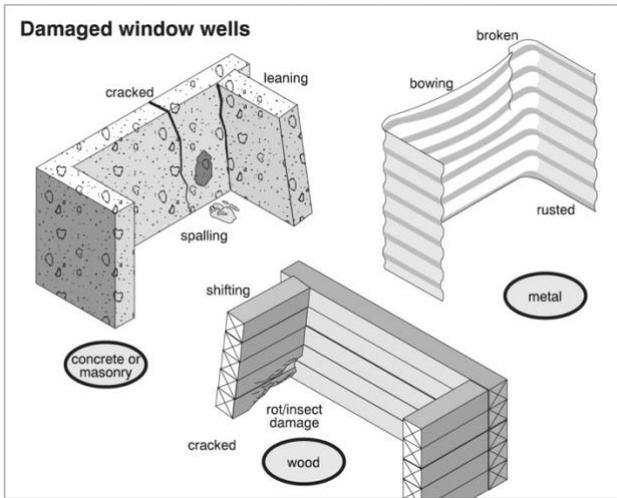
The left front basement window well has deteriorated. See photo #'s 41 & 51. There also appears to be a drain in this window well, that drains to the sump pump, that appears to be clogged. See photo #'s 89, 90 & 231. Reconstruction of or replacement of the basement window well will be required to help prevent water entry into the building from occurring. Obtaining cost estimates for any repairs or replacement is recommended prior to contractual limitations. See illustration below-

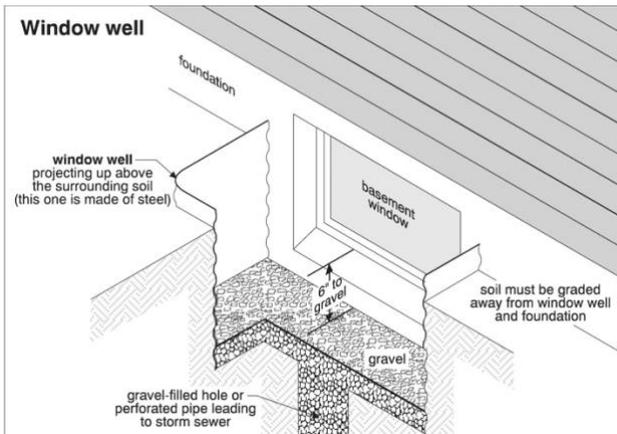
The soil level inside the two left rear window wells was too high. See photo #'s 56 & 57. Lowering of the soil level to approximately 4-6 inches below the top of the window sill and the installation of approximately 10-inches of gravel below the 4-6 inch air space will be required to function as a dry well which will help prevent water entry into the building through the basement window from occurring. See illustration below-

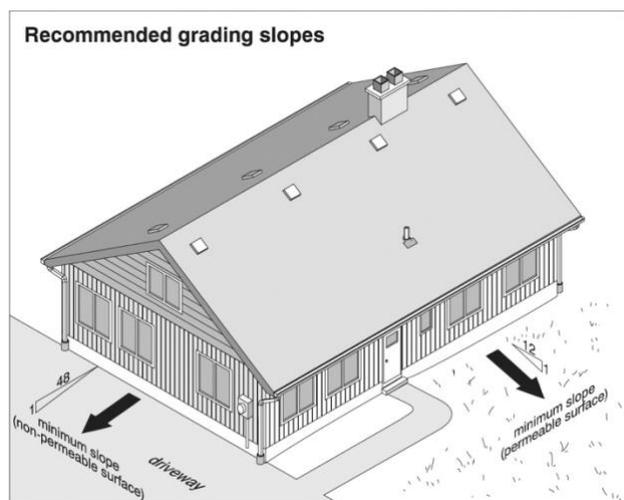
The soil grading on the front, right, rear right, left and rear left were incorrectly sloped into the foundation rather than away from the foundation. See photo #'s 39, 53, 54, 67, 69, 71 & 76. This condition will cause surface water to drain into the building rather than away from the building. Grading of the soil away from the building will be required to help prevent water from draining against the foundation and from entering the interior of the building. Obtaining cost estimates for any repairs is required prior to contractual limitations. The ground adjacent to the foundation wall must be graded to slope away from the building at a ratio of 1:12, meaning that for every 12-foot out horizontally the ground level is to descend 1-foot. This grading requirement is to be applied for a distance of 8-feet or more, measured perpendicular to the foundation wall. Please refer to Article #'s PD1, PD2 & PD3 on our website at www.NJComprehensiveHomeInspection.com for additional information on this topic. See illustration below-

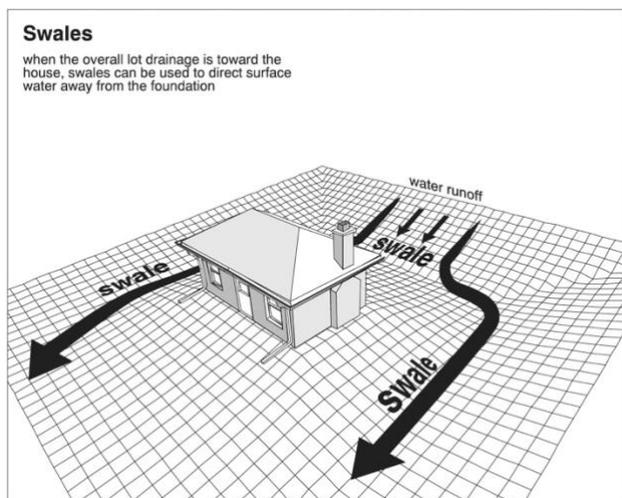
It is recommended that a drainage swale be installed in the rear yard to direct surface water away from the building. See photo # 74. A drainage swale is a gentle 'U' shaped channel formed by the convergence of intersecting slopes of soil that permits surface water to drain from a higher to a lower location. See illustration below-

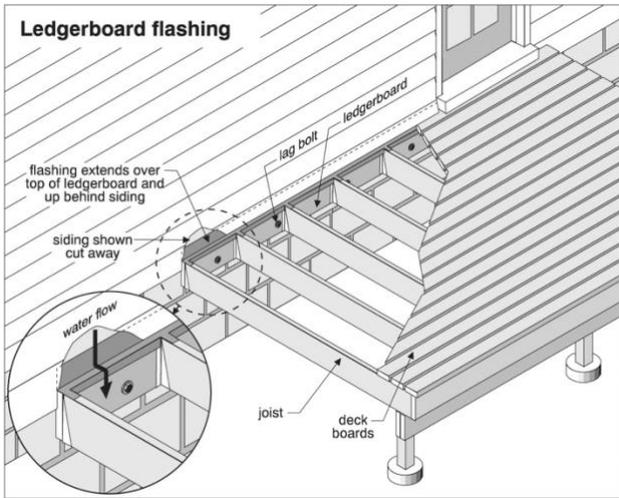
The rear wood deck: The ledger board does not appear to be properly flashed where it was attached to the building. See photo #'s 79-81. This condition will cause rotting of the building and water entry into the building to occur. Repairs may be required. Obtaining cost estimates for any repairs will be required prior to contractual limitations. It should be further noted that the new pressure treated lumber is extremely corrosive to aluminum. A corrosive resistant flashing material such as copper sheet metal flashing, a modified asphalt waterproof membrane, or a polypropylene backed copper flashing such as the York Shield 106pt. should be used. Please refer to Article #'s D1, D2 & D3 on our website at www.NJComprehensiveHomeInspection.com for additional information on this topic. See illustration below-

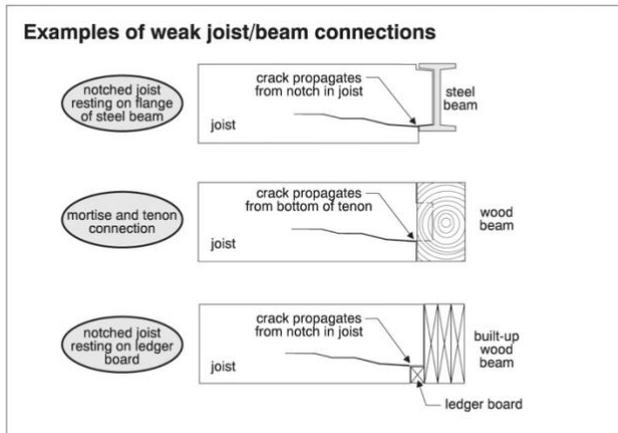
Cracks have developed in several floor joists where they are connected into the support beams. See photo #'s 154, 157 & 159. Repairs by installing joist hangers will be required to prevent further movement from occurring. Obtaining cost estimates for any repairs will be required prior to contractual limitations. See illustration below -

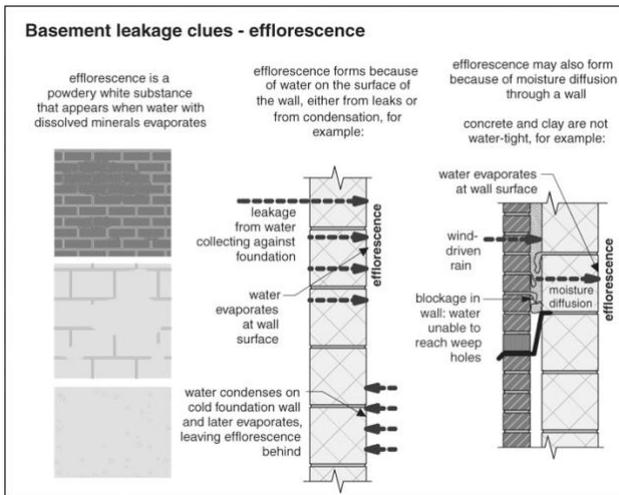
The presence of efflorescence, a condition relating to water seepage through masonry, was seen on the front, right and left foundation walls. See photo #'s 93-97, 101, 102, 104, 105, 107 & 121. As water that is inside the foundation walls evaporates, mineral salts are deposited on them leaving behind these crystalline structures. This is a condition conducive to water damage and mold. Corrections to the water entry will be required in order to correct this condition. Efflorescence is rarely a structural concern, however it is a definite sign that water is entering and moving through the foundation walls. It is also an indication that the exterior drainage is inadequate. This can be an easy fix such as directing gutters and leaders to discharge four to six feet away from the foundation. It can also be related to negatively pitched soil on the exterior of the foundation and/or other exterior foundation conditions. The exterior soil should slope / pitch, one inch per foot, eight to twelve feet away from the foundation. The exterior foundation should be well parged / plastered, without cracks, and it should be well sealed with an approved damp / water proofing material below the exterior soil grade / level. Most of these conditions cannot be observed because they are below the exterior soil grade. Corrections to these conditions and a further evaluation by a structural engineer or a basement waterproofing company are recommended prior to contractual limitations. See illustration below -

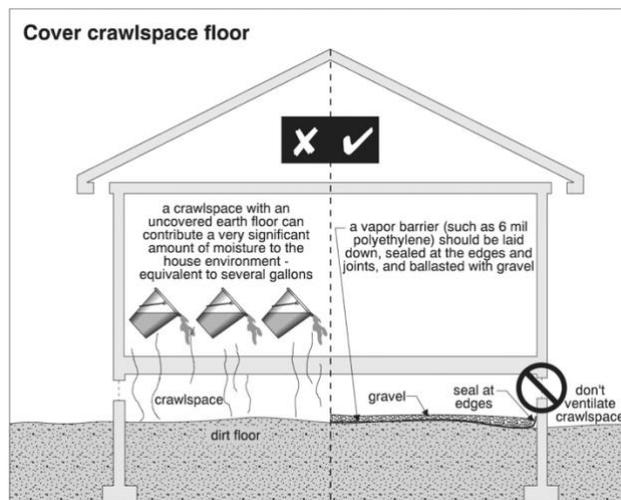
Covering of the dirt floor with 2-inches to 3-inches of concrete to act as a rodent barrier and then capping the foundation walls and the new concrete floor with 40-mil. thick plastic vapor barrier is recommended to lower the humidity and moisture level in the crawl space to act as a vapor barrier and a rodent barrier. Obtaining cost estimates is recommended prior to contractual limitations. See illustration below:

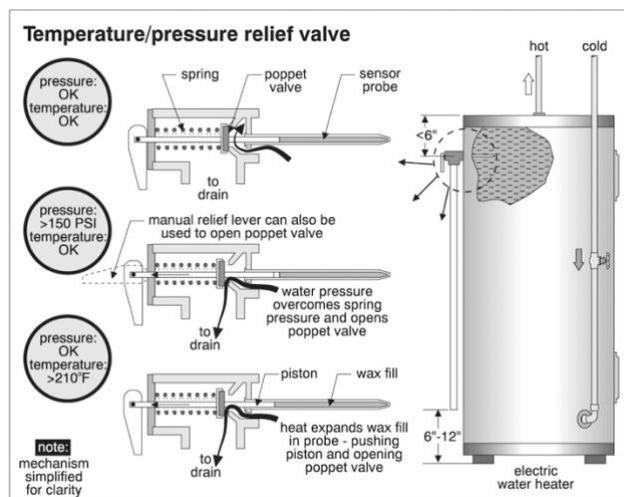
The wrong type of extension pipe (PVC plastic) was installed on the safety relief valve. See photo # 124. The installation of a copper or steel pipe the same diameter as the outlet of the temperature and pressure safety relief valve to not closer than 6-inches above the floor will be required for safety reasons as per current plumbing practices. There should be no pipe threads on the bottom end of this pipe. See illustration below-

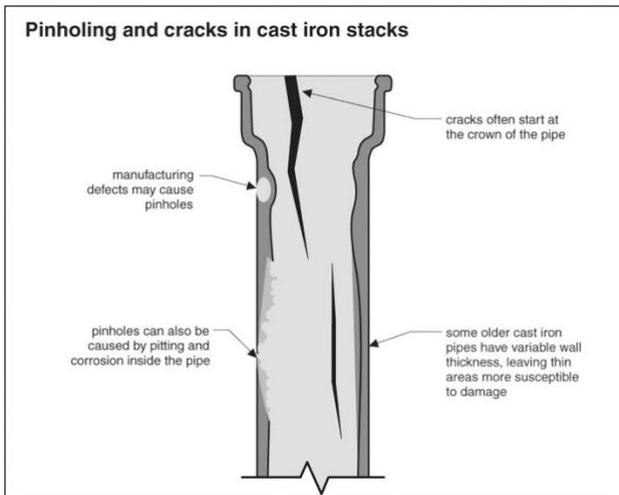
A video camera inspection of the interior of the street sewer main, from the basement to the street, is strongly recommended due to the age of this building. The sewer main appears to be the original pipe. The video inspection will determine if it has worn, cracked, is deteriorated or if tree roots are entering it. This inspection is conducted by many plumbers and should be conducted prior to contractual limitations. If you cannot locate a company to conduct this type of inspection, please contact our office for a referral. See illustration below-
