# TROUBLESHOOTING Common Chimney Problems

by Stephen Bushway

The right mortar, properly placed bond breakers, and a well-constructed crown are the keys to a long-lasting chimney

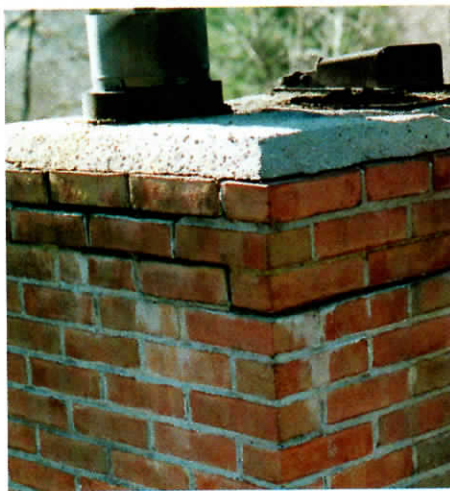
**Figure 1.** This chimney crown dried too quickly, causing the edges to curl and pull away from the masonry, allowing water to penetrate. This crown also bonded to the flue liners. When the liners expanded, they lifted the top of the chimney, causing the top three courses of brick to crack.

**Inadequate curing.** When a freshly cast crown dries too quickly, the exposed top surface sets more rapidly than the interior portion. As the surface dries, it also shrinks, pulling at the outer edges and causing the crown to curl (see Figure 1). The resulting gaps will allow water to penetrate into the interior of the chimney.

**Bonded flues.** The photo in Figure 1 illustrates another common problem. As flue liners heat up, they expand. If the crown bonds to the flue liners, the liners can actually lift the top of the chimney as they expand, stressing the mortar joints and creating cracks that allow water to infiltrate the chimney.

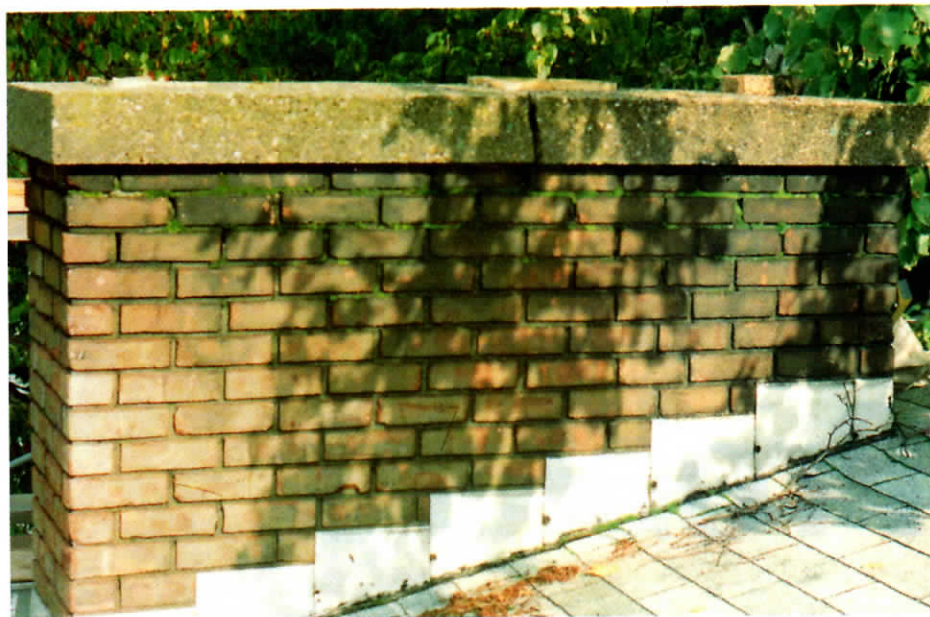
**Figure 2.** Excessive shrinking caused this crown to crack at the weakest point — the area where a flue penetrated the surface. Proper curing reduces the amount of shrinkage, and reinforcing fibers added to the concrete crown mix add tensile strength.

**Lack of reinforcement.** Even properly cured crowns will shrink as they harden. Flues reduce the cross-sectional area where they penetrate the crown, creating

weak links. As the crown shrinks, improperly built crowns will pull apart and crack at the weakest point (Figure 2).

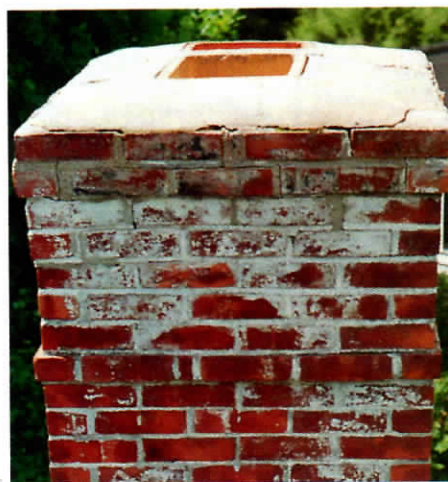
**Figure 3.** Flue liners should project at least 3 inches above the crown. Here, a thin crown and recessed flue liners caused this chimney crown to leak. As the water worked its way out of the chimney and evaporated, soluble salts remained behind, leaving a whitish stain called efflorescence.

**Feathered crown.** The mortared “wash” on the top of the chimney in Figure 3 is guaranteed to fail. My guess is that the mason ran out of flue liners before bricks. The feathered edge of the mortared wash broke down quickly, and

the recessed flue liners allowed rain to penetrate the interior of the chimney.

**Efflorescence.** The whitish haze that appears on the outside surface of the chimney in Figure 3 is called efflorescence. The staining occurs when water within the chimney works its way to the exterior surface and evaporates, leaving behind soluble salts.

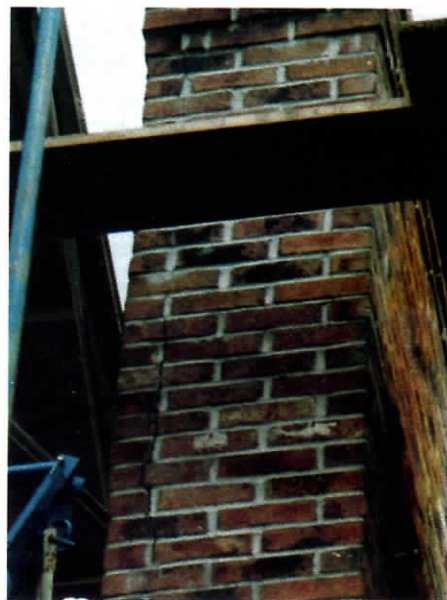
**Figure 5.** The code-required air space between the flue liners and the chimney walls allows the liners to expand and contract freely. In this chimney, the void between the bricks and the flue liners was filled solid with mortar, and resulted in a 7-foot-long crack when the liners expanded.

Recently, I was called in to repair a chimney that had a 1/2-inch-wide vertical crack 7 feet long, starting at the crown (Figure 5, page 51). I discovered that the space between the bricks and the flue liners had been filled solid with mortar. The homeowners had adapted a wood stove to the existing fireplace, and creosote accumulated on the walls of the oversized flue liners. At some point, the intense heat of a chimney fire caused the flue liners to expand, literally pushing the chimney walls apart.

The NFPA 211 Standard (National Fire Protection Association, Batterymarch Park, Quincy, MA 02269) requires a 1/2- to 1-inch *free* air space between the flue liner and the chimney wall. To stabilize the liners within this free air space, I cut strips of ceramic wool insulation (available from Sleepy Hollow Chimney Supply, 85 Emjay Blvd., Brentwood, NY 11717; 800/553-5322), and wrap the liners above and below each flue joint.

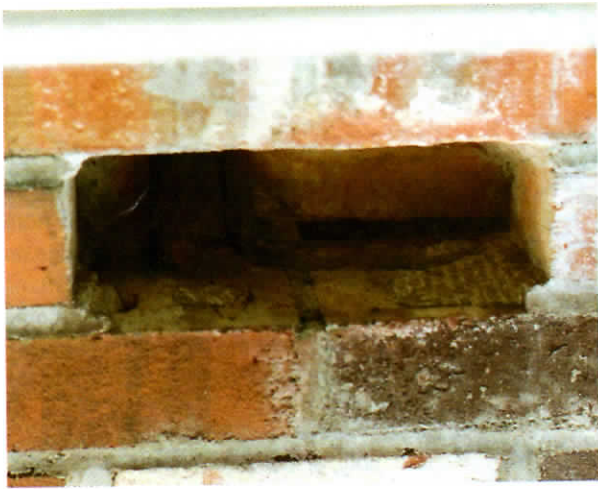
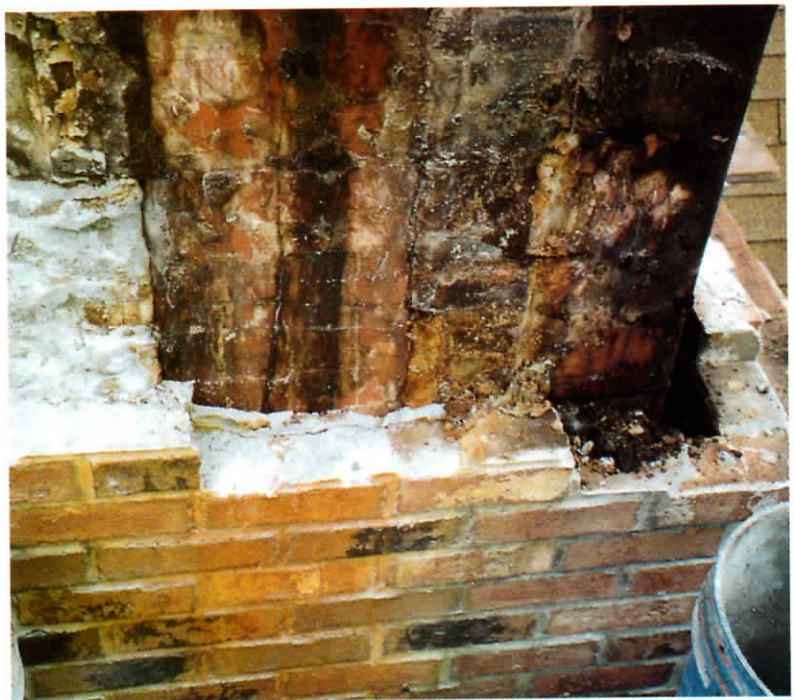
**Figure 6.** On removing a loose brick during a repair, the author discovered that the standard mortar used to set the flue liners had eroded (above), allowing creosote to leak in between the liners and the chimney wall (right). Flue liners should be set in non-water-soluble refractory cement.

the damaged bricks, I discovered that the flues had been set in conventional mortar. Portions of the joint were missing entirely (Figure 6).

Upon deeper inspection, I found that creosote had leaked into the interior of the chimney walls, causing extensive

The problem was in the mortar. Flue liners and joints need to be able to withstand the intense heat of a chimney fire and resist corrosive condensation. If standard mortar is used, the joint will eventually deteriorate.

I always set flue liners in a non-water-soluble refractory cement from Ahrens Chimney Technique. Whenever possible, I use round, lap-joint refractory flues or stainless steel liners designed for solid fuel appliances (wood stoves, for example). The stainless liners are available from Heat-Fab (130 Industrial Blvd., Turners Falls, MA 01376; 800/772-0739).

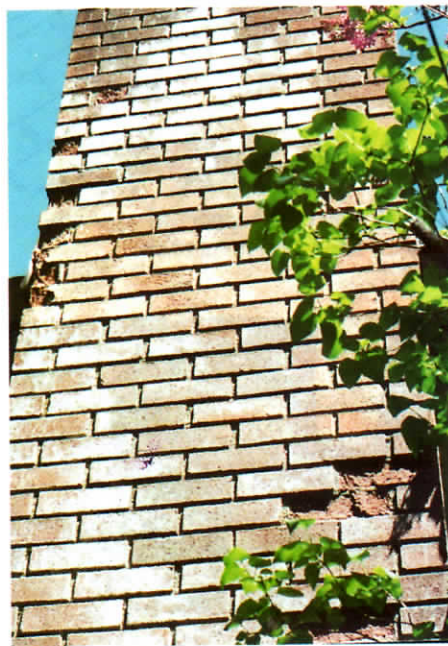
**Figure 7.** The decorative, deeply raked joints in this chimney allowed water to pool and soak into the brick. When the saturated brick was exposed to extended sub-freezing temperatures, the water froze and expanded, causing the brick to spall.

Improperly designed mortar joints can also create problems. The brick chimney in Figure 7 was built using raked mortar joints that were recessed nearly 1/2 inch, forming a shelf at each horizontal course. Rainfall tends to collect on these ledges, and if the brick happens to tilt towards the chimney core, the water can be absorbed by the brick. When a heavy rain is followed by an extended stretch of sub-freezing temperatures, the absorbed water freezes and expands, and can cause spalling.

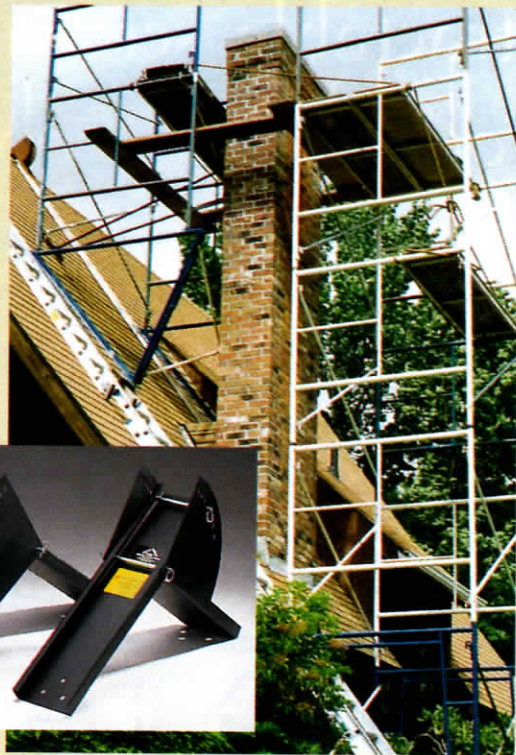
Roof-supported scaffolding increases safety, and provides a more efficient work area. The heavy-duty ridge hooks (inset) are attached to 2-bys, which provide a nail base for the adjustable scaffolding brackets (visible to left of chimney).

Two products that I have come to rely on are Ultimate Ridge Hooks, which I developed for my own work and now manufacture (Deer Hill Enterprises, 224 West St., Cummington, MA 01026; 800/588-9660), and Vanguard chimney brackets (Lynn Ladder and Scaffolding, 220 S. Common St., W. Lynn, MA 01905; 800/225-2510). The ridge hooks provide a secure nail base that is hung from the ridge of the roof, and is independent of the finish roofing material (see photo). The adjustable chimney brackets provide a level launch base for my tubular steel scaffolding frames.

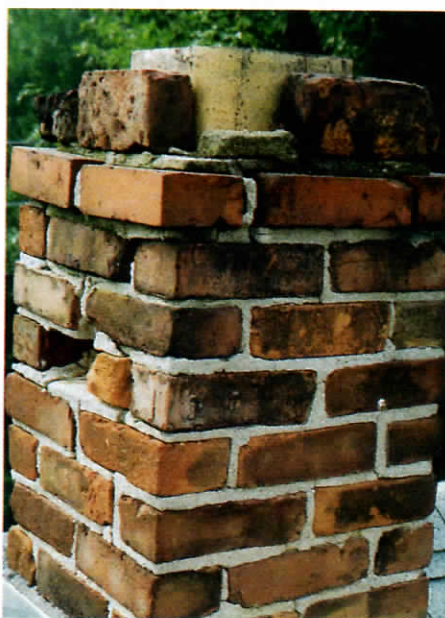
**Figure 8.** Older chimneys with deteriorated lime-and-sand mortar must be torn down to the roofline and rebuilt.

Sometimes, the problem with a chimney is just plain old age. Many older chimneys were built with weak lime-and-sand mortar (Figure 8). In most cases, I tear the chimney down to the roofline, install new flashing, and rebuild the chimney. Typically, these chimneys come apart very easily. I was able to dismantle the chimney shown in less than an hour, with hardly the need for a chisel blow.
