## A Rot-Resistant Chimney Chase

by Mark Parlee

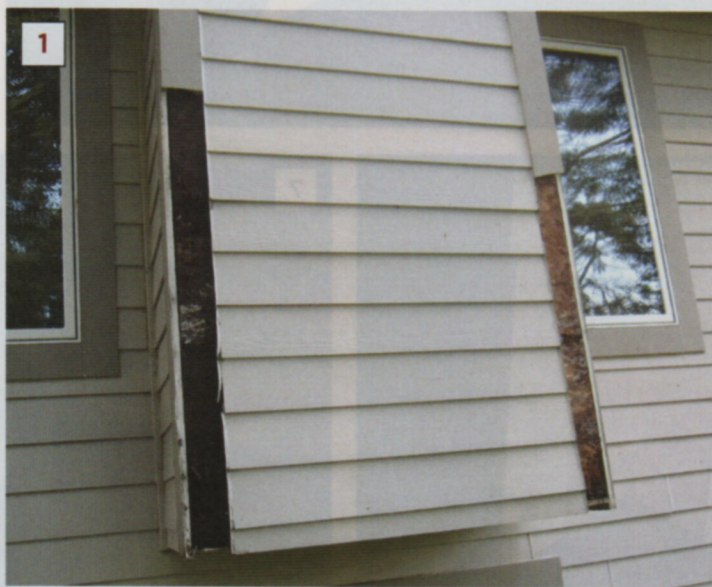
Framed chimney chases seem to be especially vulnerable, and I've repaired a lot of them over the years. For example, the house shown here was built just a few years before my crew and I began working on it, but already the paint was peeling from the fiber-cement clapboards, and the corner boards had begun to rot (1). When we dug a little deeper, we discovered deteriorated sheathing and rotted framing, too (2, 3).

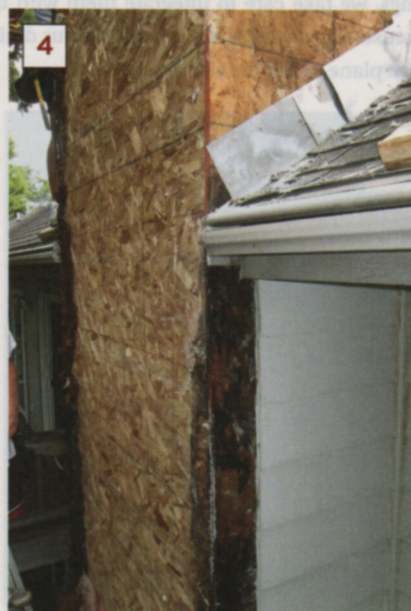
We found that most of the damage had been caused by water from the roof running behind the siding and down the sheathing — the result of some missing step flashings (4). Adding to the problem, the chase's OSB sheathing hadn't been covered with a water-resistive barrier. In an attempt to save a few hundred dollars, some builders omit housewrap over garages, chases, and gables in the mistaken belief that it's not required by code over unheated wall assemblies. In this case, a few extra flashings and some housewrap could have prevented thousands of dollars in damage.

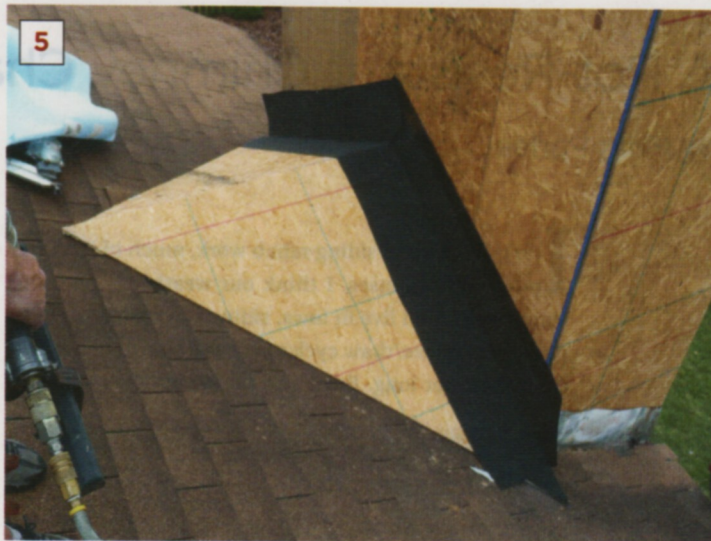
When we do a chase repair, we usually rebuild — or add — a water diverter, or cricket, at the top (5). We make the cricket wider than the chase by about 6 inches on each side. Extending the cricket past the corners helps divert water flowing down the roof away from the chase and also simplifies step-flashing installation.

Some builders omit the cricket altogether, and rely instead on a metal flashing at the roof-chase intersection — even when the chase is built on an eaves wall. But in my experience, the dam created by the metal flashing invariably fails. Crickets are more reliable, particularly in climates where snow can accumulate and lead to ice dams.

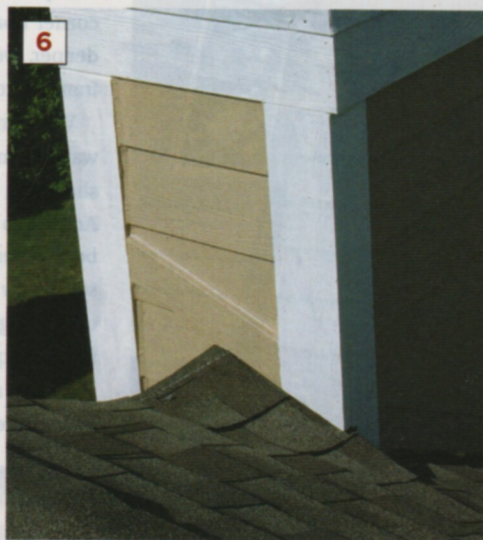
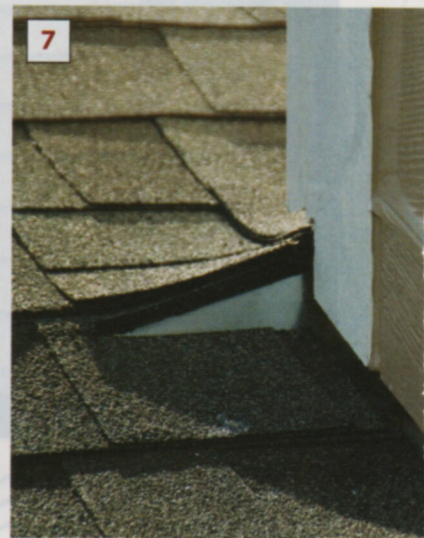
For chimney chases built into gable walls, we install a partial diverter (6), again extending the sloped surface several inches beyond the corner (7).

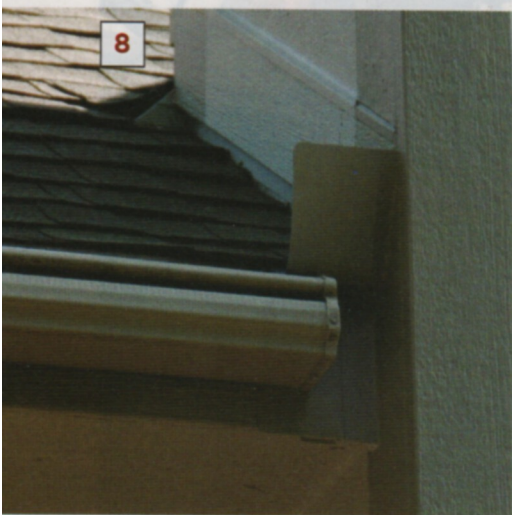
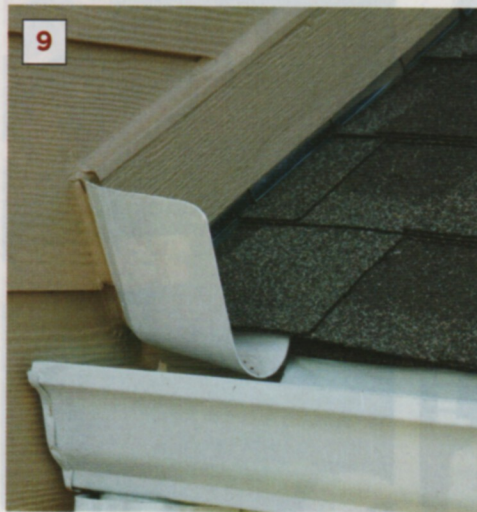
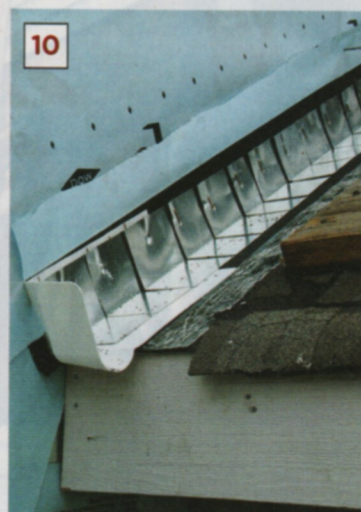
We always install diverter flashings whenever a roof intersects a wall; called “kickouts,” these keep water from running behind the cladding below and into the wall assembly (8, 9). Kickouts can be fabricated on site, but I like to use DryFlekt molded-plastic flashings (877/985-1010, dryflekt.com), which work well with various cladding materials. In the photos shown here, the water is diverted into gutters; but even without gutters, kickout flashings are very effective at protecting wall assemblies from water intrusion. As we install the flashings, we take care to integrate them with the housewrap so that there is a continuous drainage plane under the siding (10).

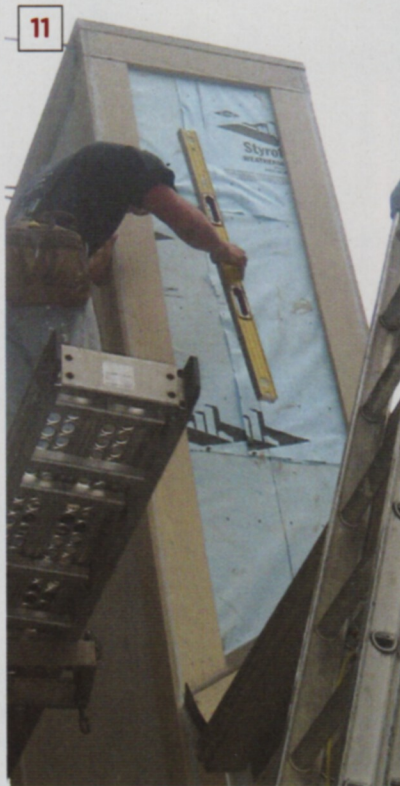
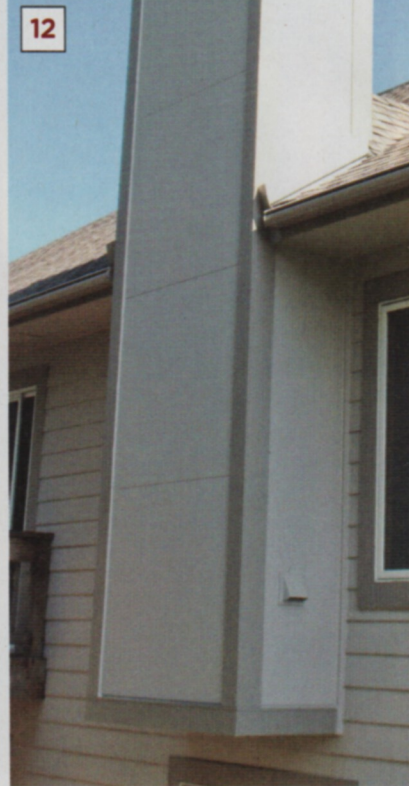
On this job, we wrapped the sheathing (11) before trimming out the chase corners with MiraTec treated composite trim, then replaced the original fiber-cement lap siding with  $\frac{5}{16}$ -inch-thick HardiePanel stucco-textured fiber-cement panels (12). I don't like the look of too much exposed step flashing, so we covered the steps with MiraTec trim installed at the pitch of the roof, maintaining an inch of clearance between the trim and the shingles (13). Some builders try to hide step flashings completely, but that's a bad idea, as this photo from another job shows (14).

We installed Z-flashing at most of the horizontal joints, and caulked the vertical joints with Flexible Seal elastomeric tripolymer sealant (562/946-8781, flexibleseal.com). Where the HardiePanels butt against each other, we left a  $\frac{3}{16}$ -inch-wide gap between panels and sealed the gaps with beads of sealant.

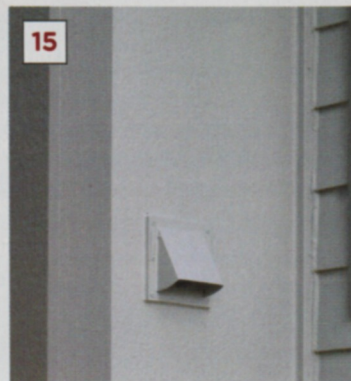
We replaced the existing plastic vent hood for the fireplace's makeup air supply with a metal one, mounting it on a PVC block and cutting the siding panel around it (15). The block

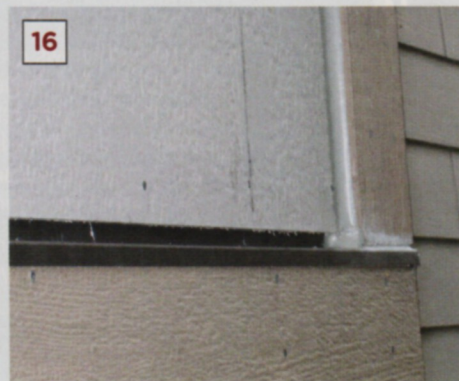
is sealed to the panel with sealant, but we left the joint between the bottom of the panels and the Z-flashing capping the trim at the chase base uncaulked, to allow any moisture that gets between the siding and the drainage plane to escape (16).
