Beating the Old Flue

By STEVE JORDAN

Steps to restoring chimney tops.

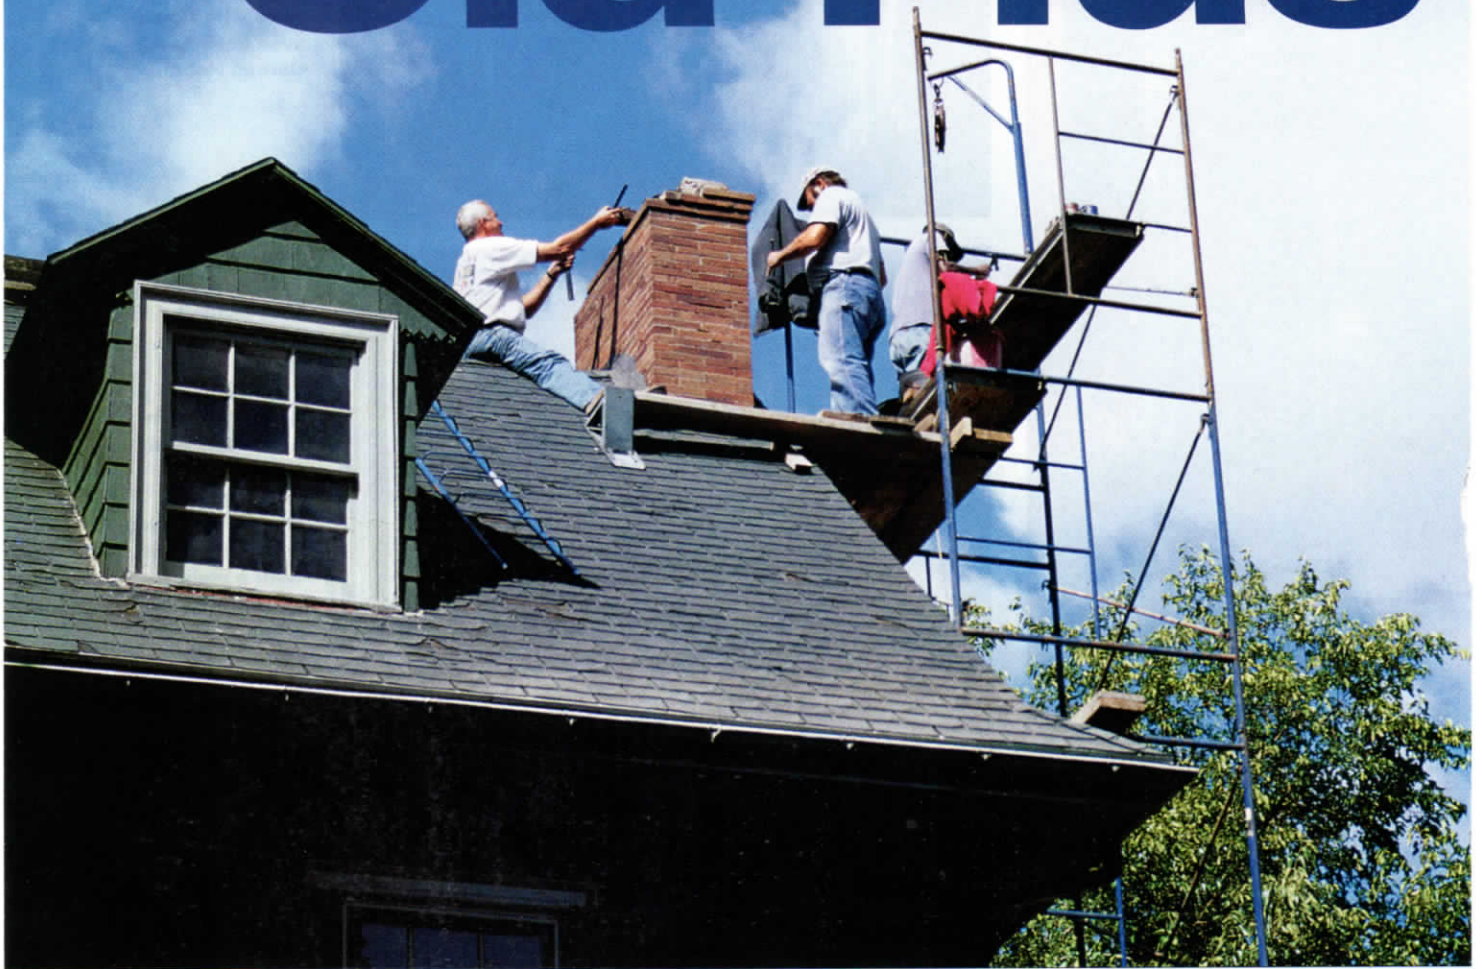
Viewed from the ground, many old-house chimney tops look sound, but it's this above-the-roofline masonry that usually suffers most from weather exposure and flue gases that condense into corrosive liquid.

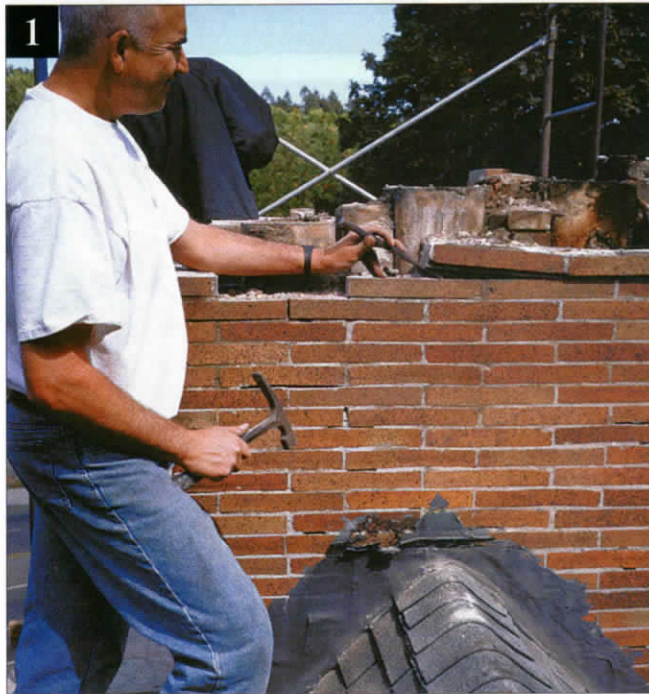
Marty Naber easily disassembled the chimney to recycle the thin Roman bricks. A shallow repointing job left much old, crumbling mortar in the joints.

pointing was shallow so the bricks were loose in their mortar beds. When I arrived, Marty had already begun disassembling the chimney—removing the bricks by hand without force and setting them aside for the next step.

Since Roman bricks are no longer available, Marty cleaned the old bricks with a hammer, chisel, and grinder for later reuse. Recycling brick is not always possible or economical, but in this case, it preserved the architectural character of the house. The clay flue liners, however, were deteriorated from years of flue gas that slowly ate away at the clay. These were easily removed and discarded once the brick was gone.

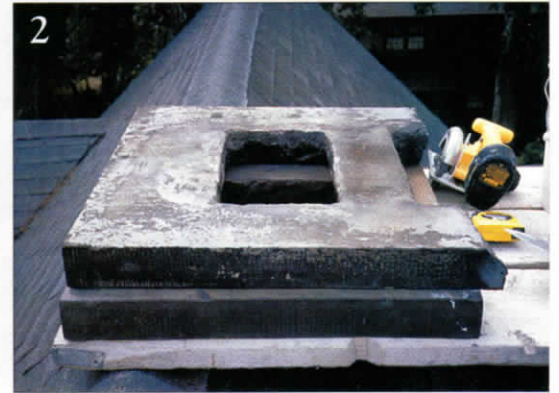
The original cap was a piece of stone, now broken, that protected brickwork while it covered the voids between bricks and flues.

The original cap was broken, so the last phase of the project was to pour a new concrete cap in its place. To cast this cap, Marty first assembled four angled metal forms around the perimeter of the chimney to hold the wet concrete. Next he wrapped the flue tiles in 1/4" closed cell foam to leave an expansion joint between the concrete cap and the clay liners. Then after laying in a 3/8" "pencil rod" reinforcement bar to strengthen the cap, Marty began pouring a mix of 5,000 psi concrete into the form—one bucket at a time—until full. As the form filled, Marty tapped the sides of the forms to release air bubbles trapped in the mix.

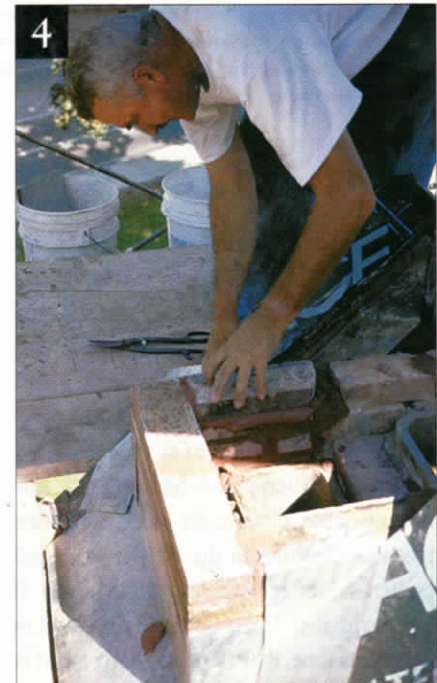
With tiles gone, Marty begins rebuilding the chimney with the first course of brick at the roofline, just below where he will set the flashing.

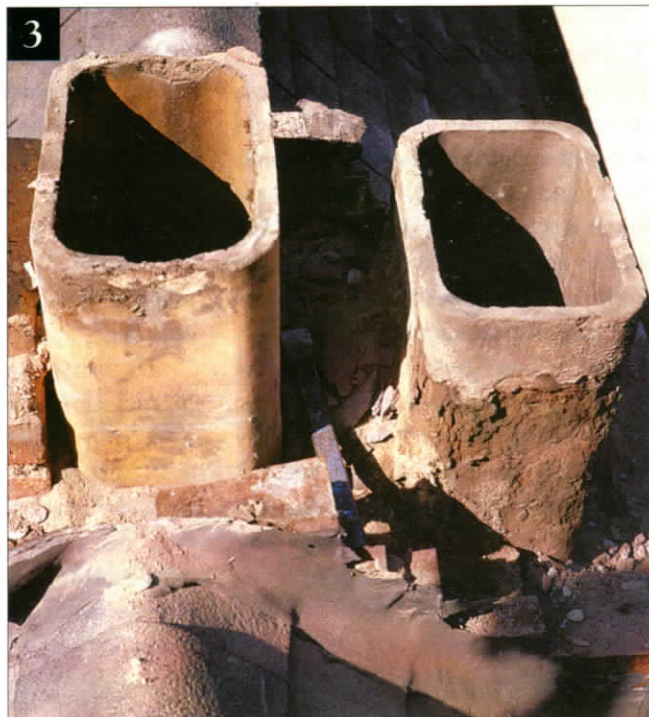
Once the chimney was disassembled, it was easy to see the deteriorating clay tile liners and remove them—down about 36" for one flue.

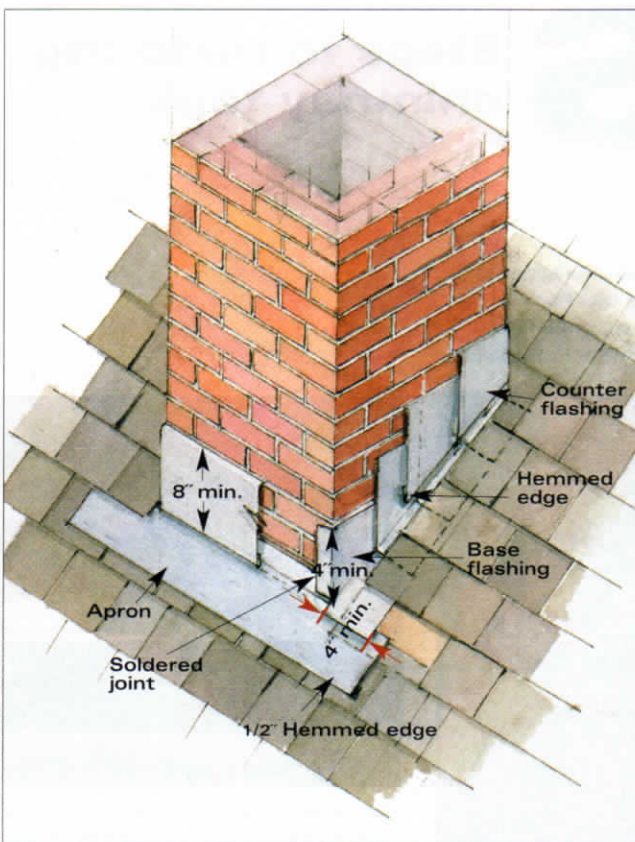
Chimney Flashing

Two-piece step flashing can be installed in a variety of ways, but the method shown above is typical. An apron flashing lies atop shingles below the chimney, while pieces of base flashing installed with each course of shingles run up the sides a minimum of 4." Counter flashing set into reglets in the mortar joints then laps over the base flashing.

using his level and the rigid edge of the scaffold plank. As the work proceeds, he weaves his metal under the shingles forming the base flashing. Then he forms a short but adequate right angle bend on the counter flashing and bars it on the end with tin snips for grip as he sets it in the mortar joint. As the courses rise, Marty's technique creates a one-piece stepped flashing system. Chimney flashing is also commonly installed as a two-piece system that allows the base flashing to be changed when replacing the roof while still retain-

ing the counterflashing attached to the chimney (see drawing on previous page).

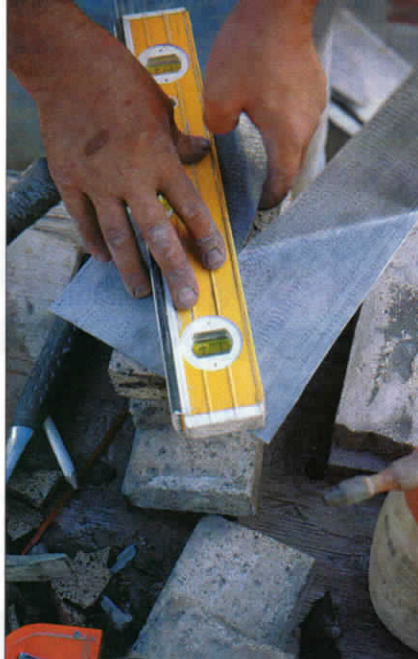
Marty bends his flashing right at the chimney and forms strips of lead-coated copper into a single piece flashing using his level as a form. Lead coated copper is popular for some roofs because of its grey color.

As Marty carefully laid up the new courses of brick, he installed new flashings of 20-ounce lead-coated copper to ensure a waterproof transition between the chimney and the roof. Many sheet-metal craftsmen use a special metal-bending tool called a brake to form flashing, but Marty expertly bends his flashing on the roof

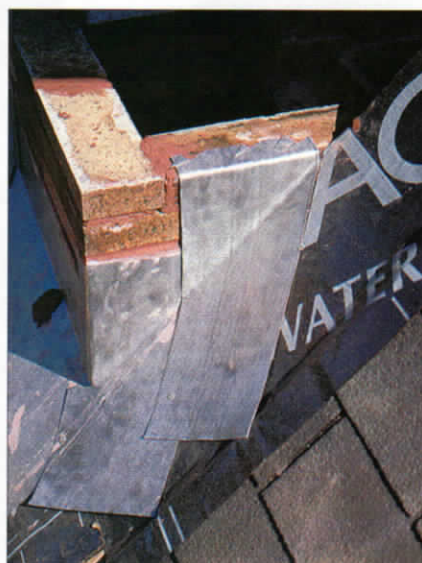
As each brick course gets another piece of sheet metal, the flashing builds into steps. Note how the metal edge turned into the mortar joint is fashioned into cut-out burrs to anchor into the mortar.

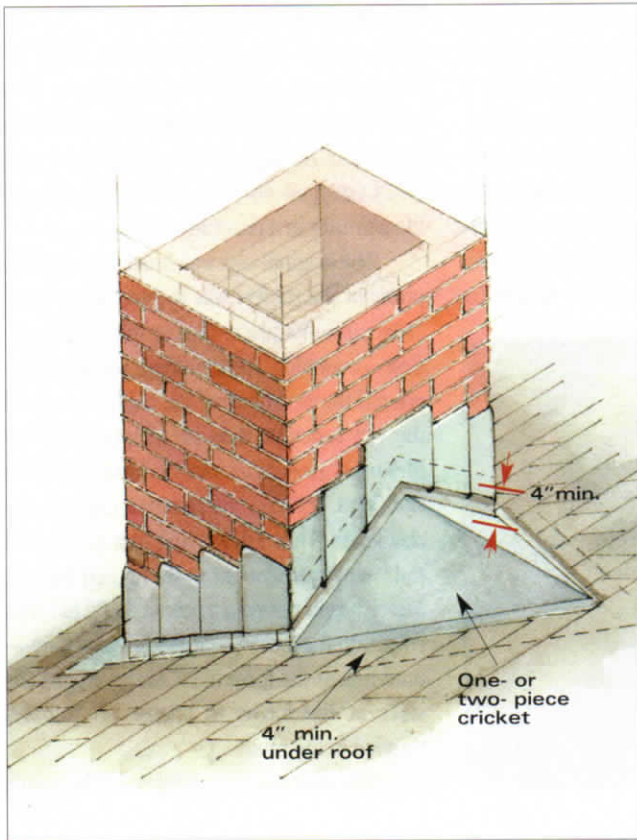
Saddle flashing, also called a cricket, is customary to shed rain and snow on chimneys that don't penetrate the roof at a ridge. Saddle flashings extend a minimum of 4" out onto the roof deck and 4" up the chimney, where they are lapped by counter flashing. Large saddle flashings are supported by wood framing underneath.

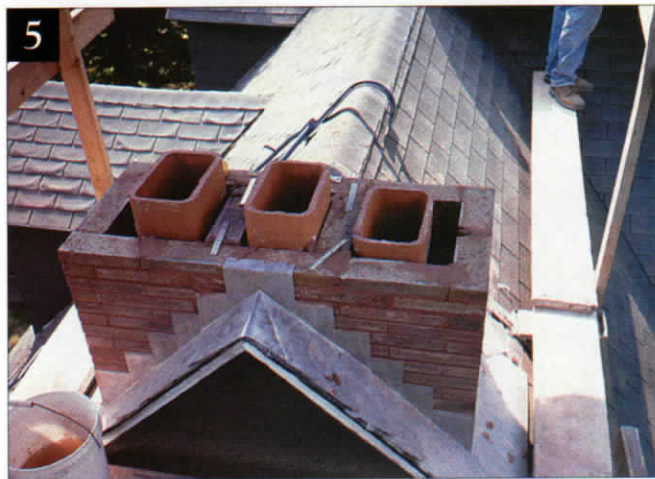
The basic chimney rebuilt with original bricks and new flue tiles is ready for the corbeled top and cap. Note the completed flashing and the metal ties securing the bricks between the liners.

While Marty laid the courses of brick, he installed new replacement clay liners that match and join up with those in the rest of the flue below. As he neared the top, Marty corbeled (stepped out) the bricks to terminate the chimney in a decorative flare.

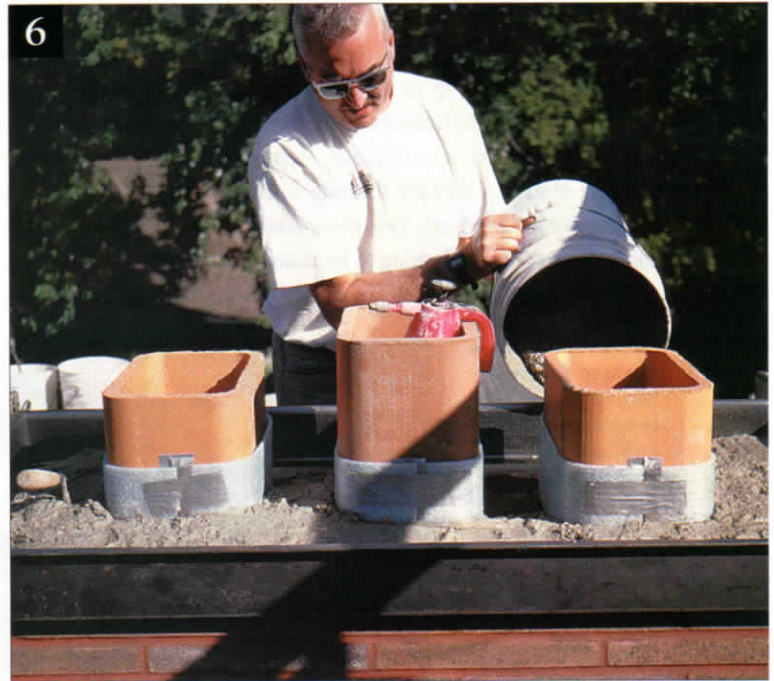
After corbelling out the flared brick top, Marty attaches metal cap forms, then pours in buckets of high-strength, premixed concrete mortar (Quickrete 5000). Wrapping the flue liners with thin, closed-cell foam (the same material used for sill insulation) prevents the mortar from adhering to the tile.

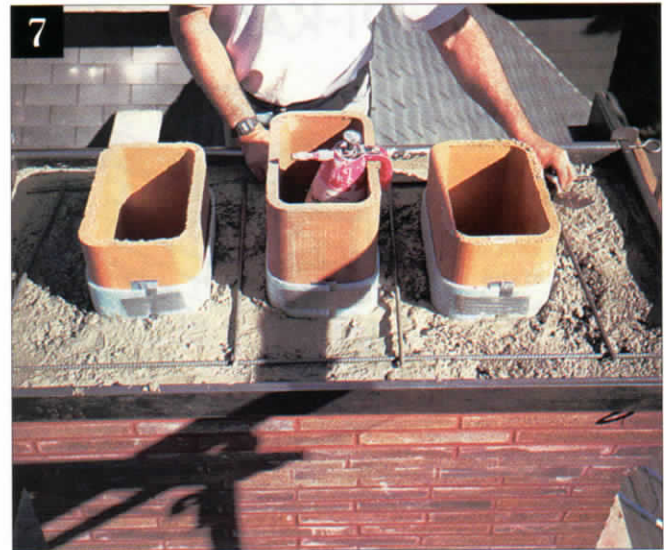
When the form is partially filled, Marty inserts lengths of steel "pencil rod" to reinforce the concrete cap. Finding matching clay flue tiles was not a problem on this project. Most of the old sizes are still available, although small dimensions such as 4" x 12" and 4" x 16" may have to be special ordered.

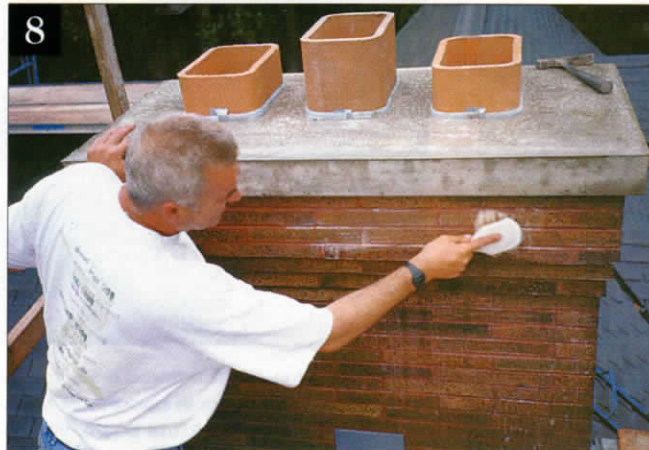
After he removes the cap forms, Marty cleans the brickwork and cap before proceeding with the final steps, such as cutting the drip reglet under the cap, cutting back the foam, and caulking the joint around the flue tiles.

from the freshly set concrete. He mixed a small amount of portland cement, sand, and bonding agent and rubbed it into the pin holes and imperfections in the surface of the cap. A few days later, he cut back the foam wrapped around the new flue tiles, filled the joints with a durable flexible silicone sealant and applied a coat of sealer (Conproco K-88) to the cap to prevent water penetration. Last, fitting a diamond blade on his grinder, he cut a drip reglet on the under side of the cap overhang to prevent excessive amounts of water from running off the cap and creeping back onto the brick.

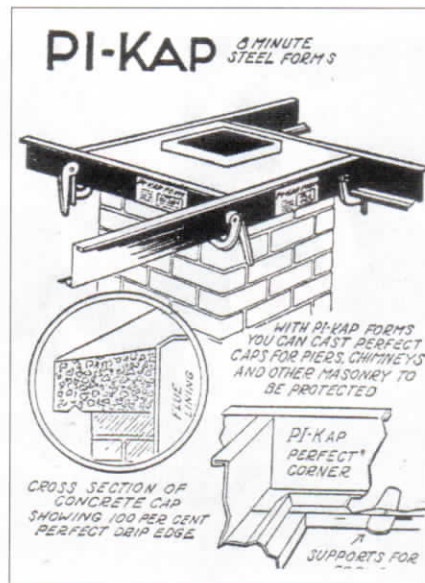
Right: Today's universal chimney cap forms work essentially the same way as the first versions that appeared in the 1910s. The PI-Kap advertised in 1929 even cast a drip reglet in the cap bottom.

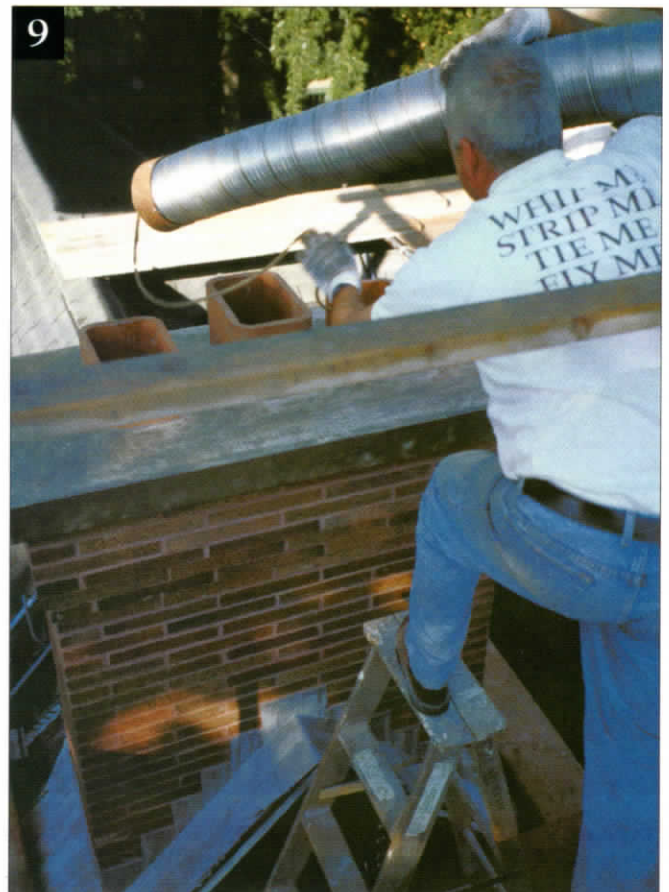
Right: To bring the furnace flue up to code, Marty installed a stainless steel liner by starting at the chimney top and pulling the liner through the flue with a guide rope.

Since Al and Barbara's house was fitted with a recent high-efficiency gas boiler, the final step in rebuilding the chimney was to install a metal flue liner in the aging clay flue to meet the building code. Marty and his crew prepared the top quality, 316 TI-alloy stainless flexible liner on the ground and attached a messenger line that would help pull it through the chimney. When finished, the chimney was ready for another generation or two of heating in Rochester winters. 🏠

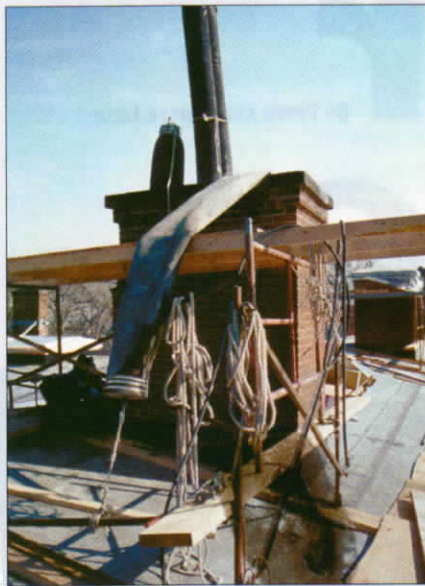
Cast-in-place liner systems form a seamless conduit inside the chimney masonry using lightweight, cementlike materials and proprietary methods, such as this inflatable bladder device.

There are three main types of flue liners: clay tiles, metal conduits, and cast-in-place systems. Consulting a chimney inspector and assessing the construction of your chimney and the nature of your heating system will determine which is appropriate for your old house. If your furnace is powered by gas, for example, either an aluminum or stainless-steel liner may meet code. If your furnace is powered by fuel oil, you'll need a stainless-steel liner.
