DECKS

Common Deck Stair Defects

Build deck stairs according to best practices rather than code to protect your customers and avoid liability

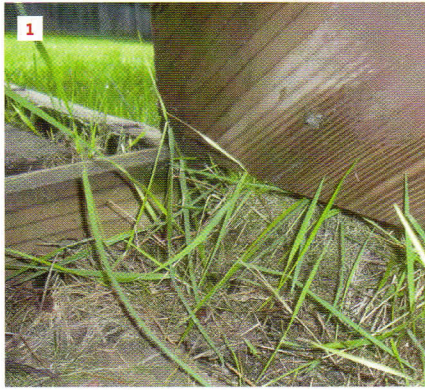
TOP ROW: The bottom of the stringer also needs adequate bearing: At least 1½ inches of the heel of the seat cut should bear on the landing. This example (1) is prone to splitting along the grain. Stringers also require adequate bearing on either a rim joist or a dropped header. Without it, the stringer can split along the grain (2, 3).

It's best if the entire stringer seat cut bears on a solid landing, but at minimum, at least 1½ inches of the seat-cut heel should bear on the landing. Allowing the toe of the seat cut to be the only part of the stringer that bears on the landing can cause the stringer to shear along the wood grain (1).

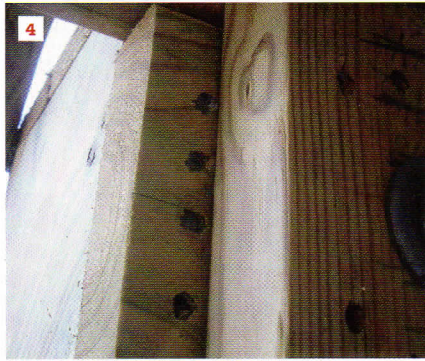
SECOND ROW: Fastening stringers with nails through the header into the end grain of a stringer (4) has minimal resistance to withdrawal. Toenailed stringers are less susceptible to withdrawal, but the connection can still fail as the framing ages and is structurally compromised (5). At a cost of a few dollars each for the connectors and recommended fasteners, the most cost-effective way to hang a stringer is with metal hardware. But this one (6) has been installed incorrectly: The stringer isn't fully bearing on the connector seat. Another red flag: The fasteners are drywall screws instead of approved connector nails.

with nails driven into the stringers' end grain (4). If the stringers are also bearing on—but not attached to—a landing and have no other attachment to resist lateral loads, the nails will do little to prevent the stringers from pulling away from the framing. If the stringers are bearing on the ground, the problem is even worse.

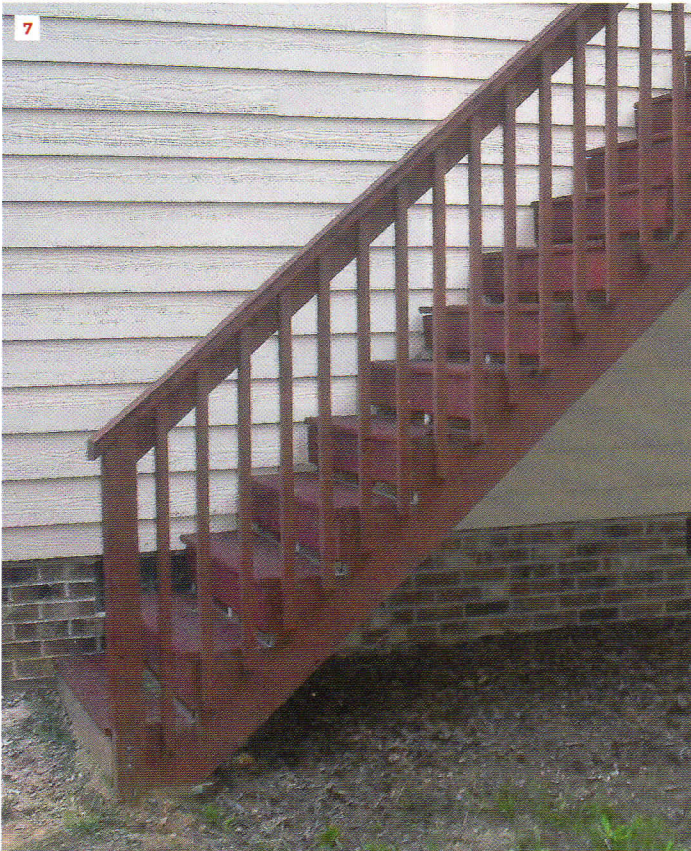
A 2x12 stringer has a maximum unsupported span of 6 feet. These stairs (7) are likely to deflect and cause the stringers to either pull loose from the framing or shear along the grain. The problem is made worse with overcut notches, which weaken a stringer (8). The minimum recommended depth of the uncut portion of the stringer is 5 inches, as measured to the closest saw kerf and not the notch itself. Shown in the illustration on the facing page are the recommended standards for deck stair guards, which are subject to the same requirements as interior stairs.

The minimum recommended size for a deck stair stringer is 2x12, which has a maximum recommended unsupported span of 6 feet. Often this maximum span is dangerously exceeded, resulting in overspanned stringers that will deflect and cause the connection at the deck to pull loose and fail. In some cases, overspanned stringers may shear along the wood grain (7).

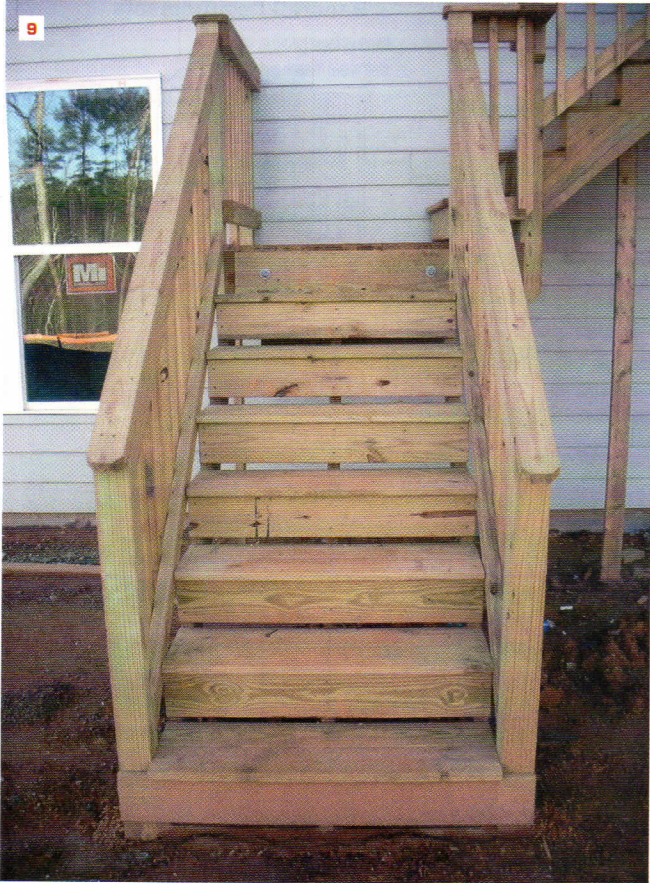
Though common, 2x4 handrails (9) are not considered graspable and should be avoided. Bottom guard rails on stairs should be oriented close enough to the tread nosings so that a 6-inch-diameter sphere will not pass through the triangle created by the riser, tread, and rail (10). Wooden stair guard posts should be located so that the span between posts (as measured horizontally) is no more than 6 feet. This is a new deck stair that passed inspection (11).

Like deck stair guards, deck stair handrails share the same requirements as for interior stairs, including requirements for a graspable shape and termination in a post or a return. This means that very few deck handrails comply with code or best practices, including those with typical 2x4 and 5/4 rail caps (9). A 2x4 handrail is not graspable, especially by children and others with small hands, the elderly, and those with impaired mobility—the people who need a safe, graspable handrail the most.

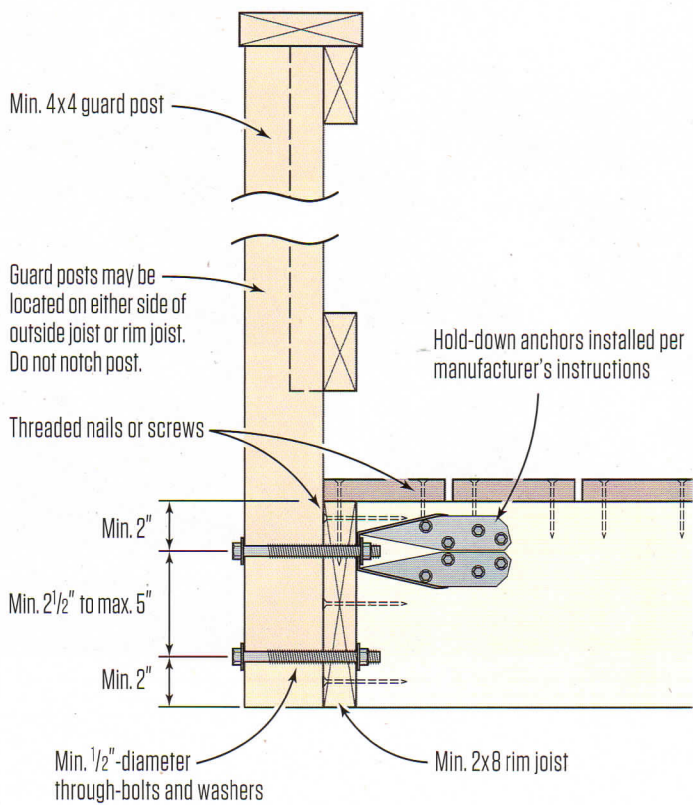
Guard Post Fastening

A strong connection between guard posts and deck framing is critical to deck safety. The illustration (above left) shows an example of a connection made with a metal hold-down anchor, and details the other DCA 6 fastening requirements for guard posts. Above all, avoid notched posts (12), which may develop cracks originating in the corner of the notch and running parallel to the grain, which weakens the post.

Guard posts must be able to withstand a 200-pound load in any direction. The easiest way to comply with this requirement is to install hold-down connectors, especially at the top of the stairs, following the manufacturer's instructions (see "Guard Post Fastening," above).
