Federal Pacific Electric

Douglas Hansen & Redwood Kardon

Code

Check

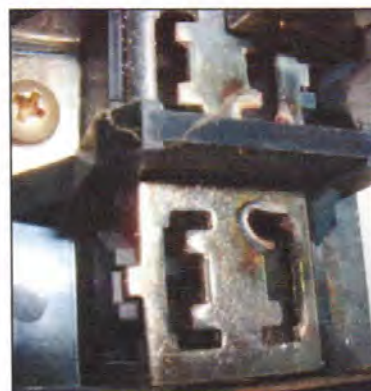
Figure 4 - Aluminum Sockets

Early FPE equipment had copper bus bars with the sockets cleanly defined (figure 3). Later FPE equipment used plated aluminum, which appears to have been stamped (figure 4). Some edges of the socket opening are slightly bent on these later models, further reducing the contact area of the breaker to bus connection.

Damage such as seen in figure 4 is quite common, though it cannot be seen until the breakers have been removed.

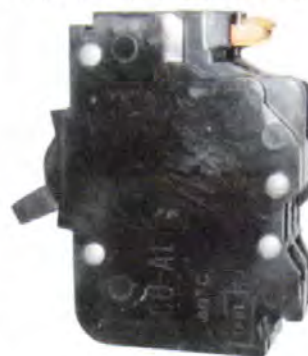
Fig. 5 - 2-pole E Breaker

FPE breaker stabs were copper and formed with a bend to exert pressure on the edges of the bus socket. Pointed ends help guide the bus stab into the socket. The stabs on E breakers are remarkably fragile; and are easily damaged during installation. If the breaker has been pulled back out of the bus, the bus stabs become distorted and are often no longer parallel. The tension between the two stabs may be lost, and they do not securely snap into place. Loose breakers are a common problem with FPE. These loose connections overheat, and it is possible for arcing and damage to have taken place behind the breaker without visible damage to the front of the breaker. The damaged bus is not visible until the breakers are removed. The F bus stabs (figure 6) are more robust; the metal is more than twice as thick, and they are 3 times as wide as the E stabs (figures 5 & 7).

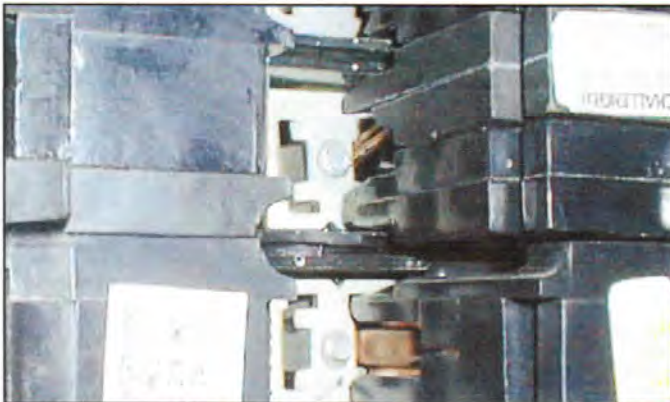
Fig. 8 - E Stab in F Socket

However, by bending the stab an E breaker can be forced into an F slot (figure 8), though this will damage the breaker. The plastic case may split open and the bus stab can recede into the breaker, as in figure 7. Since it then has very loose contact to the bus, the breaker might fall out when the deadfront cover is removed. Inspectors can be forewarned of this condition before taking off the cover. Look at the panel label to see where the E slots are located and whether any E breakers have been inserted into F slots. When finding that situation, there is no need to remove the cover to know that the breaker is in the wrong position.
