# Troubleshooting Brick Veneer

Missing through-wall flashing and clogged cavities spell disaster

by Harrison McCampbell

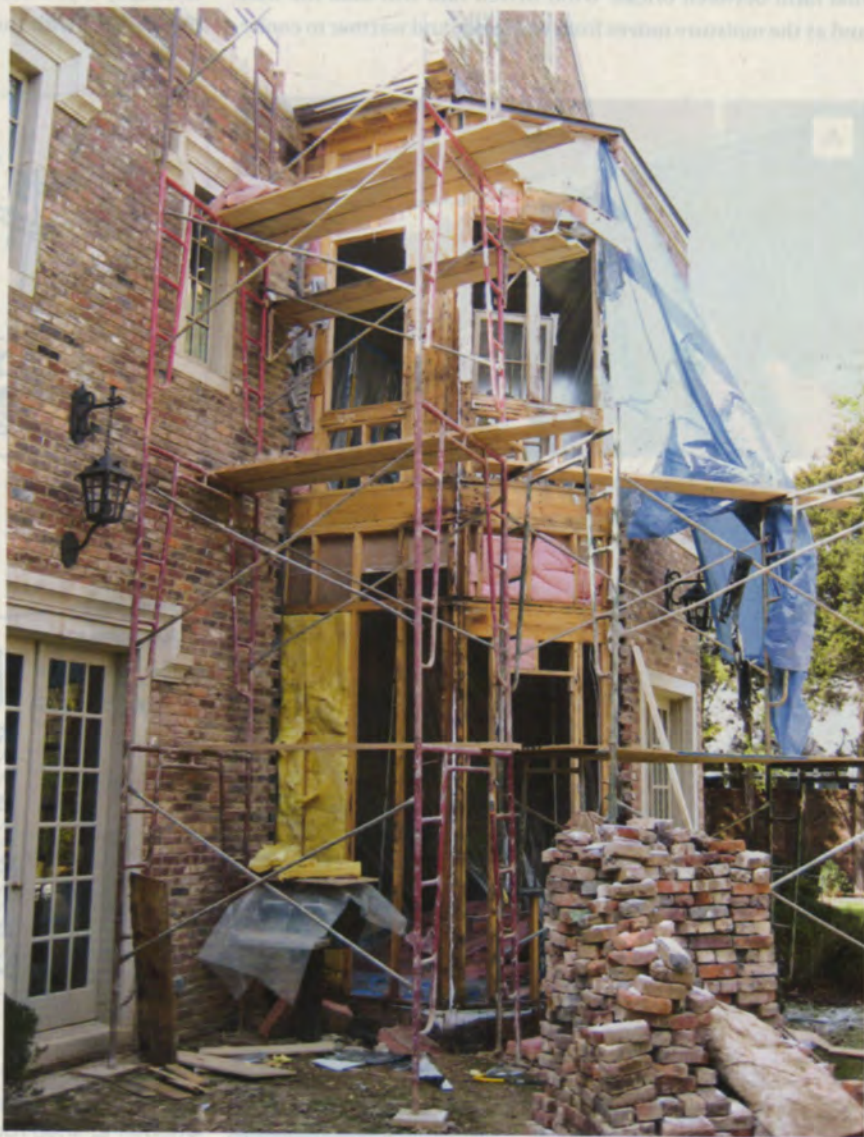
Take the house in the photo at right. The owners reported recurring leaks and damage to pricey custom finishes inside. By the time I was called in, they were understandably upset at the many failed attempts to fix the problem. Typically in a case like this, the "repair" consists of applying tubes of caulk or mastic around windows and flashings — inevitably a waste of time. As you can see from the photo, getting to the root of this house's problem was a little more involved than that.

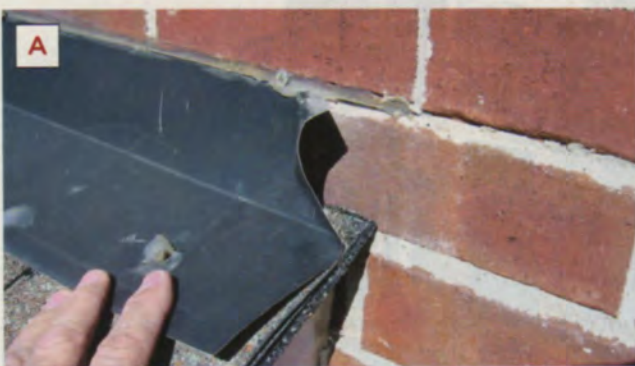
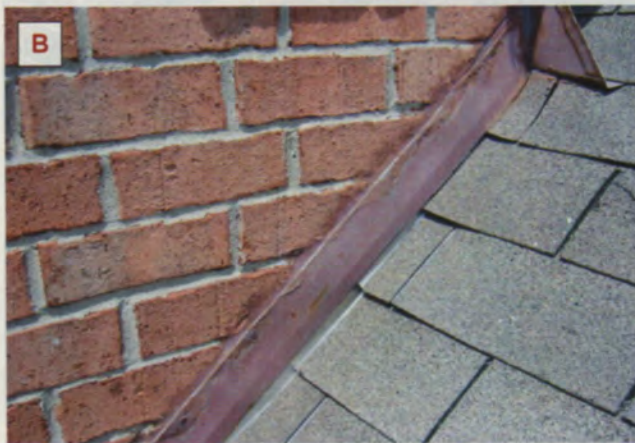
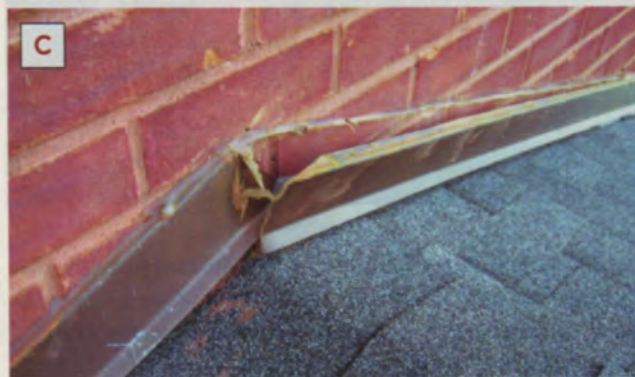
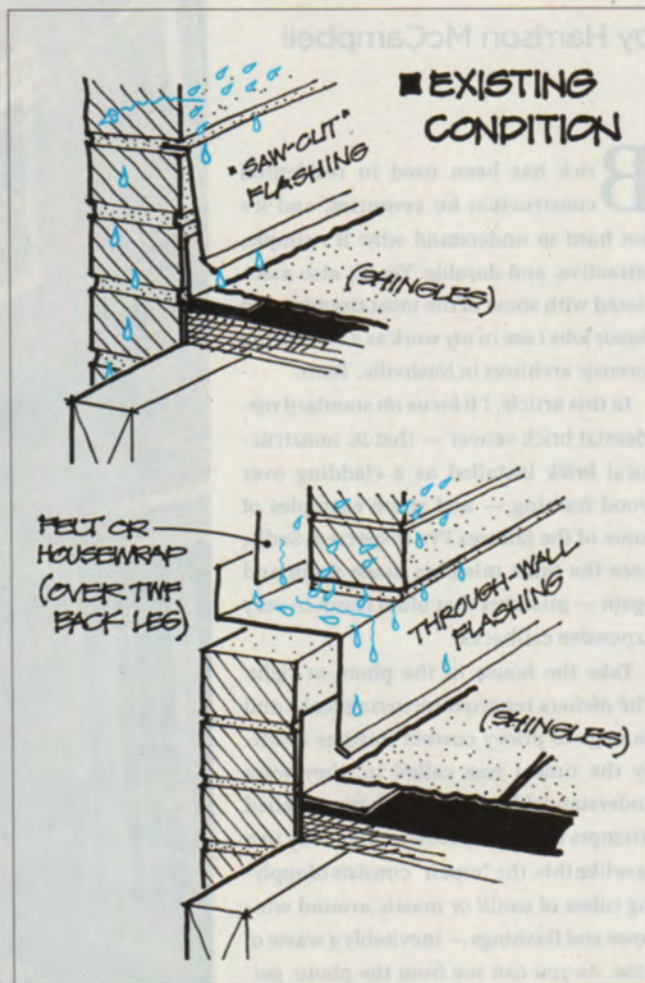
The main cause of moisture problems in the brick homes I investigate is the lack of proper through-wall flashings (see Figure 1). For example, one common source of leaks is the counterflashing installed where a sloped shingle roof abuts a brick wall. The metal is usually 4 or 5 inches high, follows the shingles in a straight line parallel with the roof, and may have an occasional fastener

**Figure 1.** Counterflashings installed in saw-cut kerfs, whether at shed roofs (A) or sloped roofs (B, C), do nothing to divert water from the cavity behind the brick. These installations have a high rate of failure; copious amounts of caulk and the presence of nails or screws are dead giveaways that the flashing is useless. The sketch above, made by the author during a site visit, explains to the client the difference between a kerfed-in and a through-wall flashing.

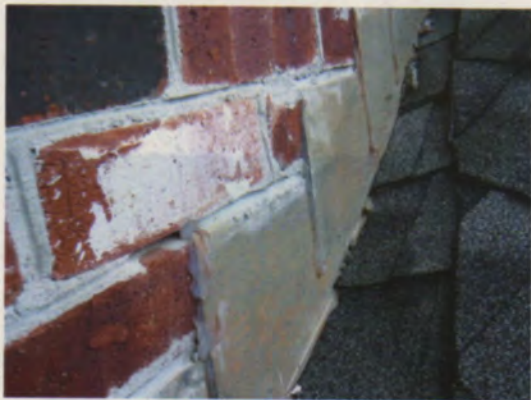
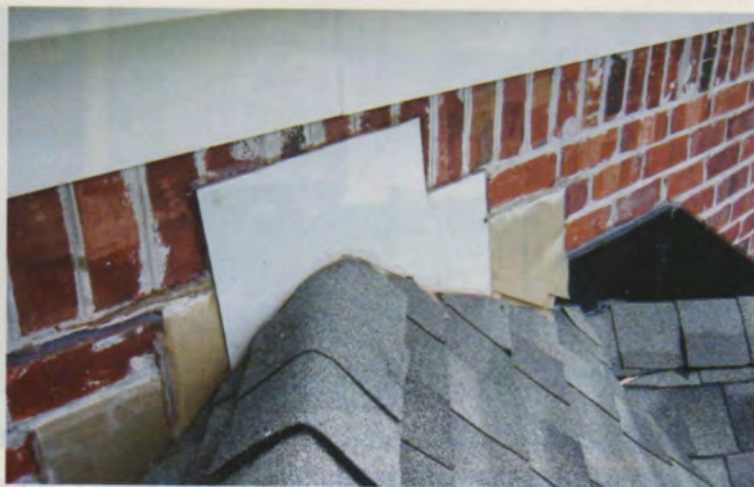
**Figure 2.** Stepped counterflashings installed in mortar joints (above) are no better than saw-cut flashings at diverting water from the cavity — unless they happen to run through to the sheathing and tuck under the building paper, which is rare. The work often gets sloppier where the installer thinks no one will see it, as in this bungled mishmash of surface-applied metal (right).

through its face into a mortar joint. Typically, the suspect flashing is turned in about  $\frac{1}{4}$  inch to  $\frac{1}{2}$  inch along the top and simply let into a kerf cut in the mortar or brick with a masonry blade. But the biggest warning signs are the nails and the copious amounts of caulk along the top edge. Even when I find the metal installed in stair-step fashion down a brick wall, it's still most likely a saw-cut job, where the counterflashing was installed after the brick had been laid (**Figure 2**).

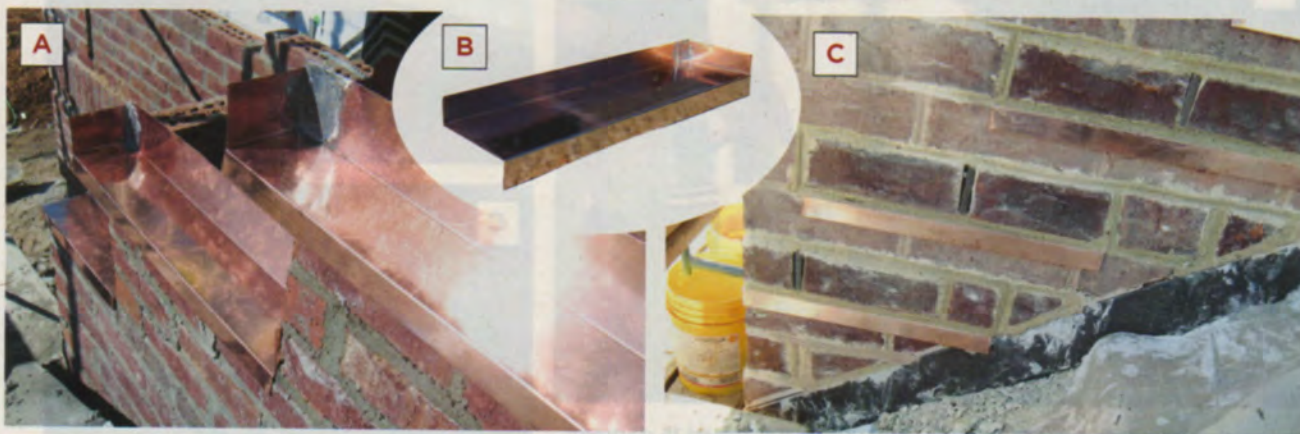
**Figure 3.** A properly flashed sidewall uses through-wall pans with soldered end dams (A, B), installed in stepped fashion as the brick is laid. Once the through-wall flashings are mortared into place (C), the roofer will install step flashings, followed by copper counterflashings that are secured to the through-wall hems with pop rivets. Note the wasp screens on the weep joints.

Unfortunately, the kerf method appears to have totally replaced use of proper through-wall flashings at roof-to-wall intersections. Admittedly, doing the job correctly is a detailed process that requires coordination between the roofer and the mason (**Figure 3**). But it's the only way to guarantee that water entering the brick

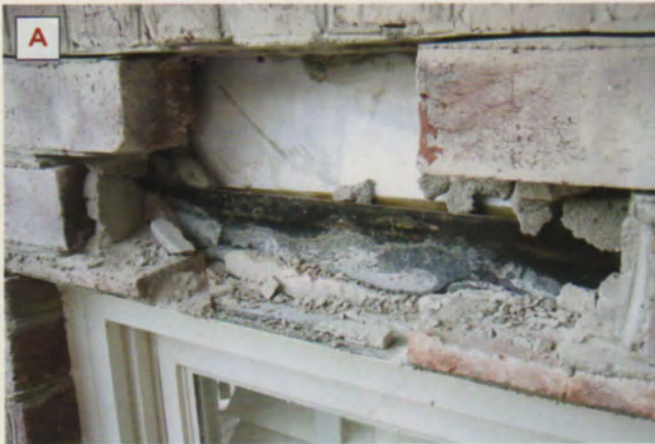
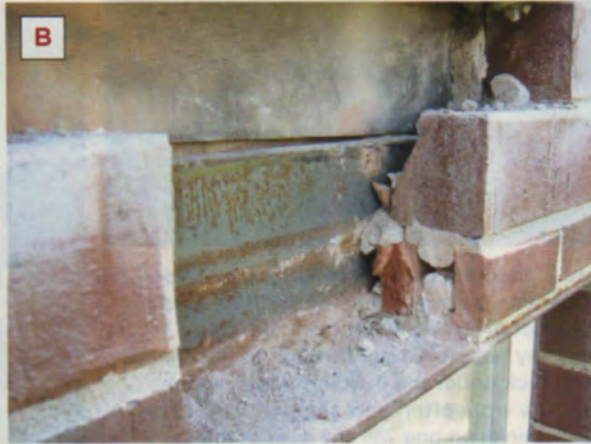
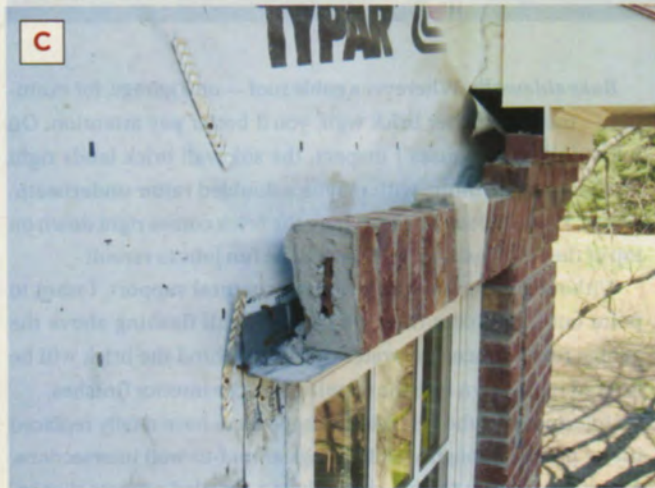
**Figure 4.** The rubber flashing tape intended to direct water onto the steel lintel (A) has pulled away from the housewrap and is instead directing water into the framing. Here (B), a metal flashing above the window just misses the lintel. Note the amount of mortar clogging the cavities in both cases. At left (C), a failed job required all the brick to be removed, revealing improperly flashed lintels at the windows, as well as ties that were never used.

**Window and door heads.** There should be through-wall flashings below the first course of brick along the top of windows and doors. The steel angle is for structural support only; it should not be used for flashing. For example, some contractors will lap the felt or housewrap over the top leg and rely on the angle to keep water out. More often, though, there's no flashing anyway, and the steel is installed on top of the housewrap (Figure 4).

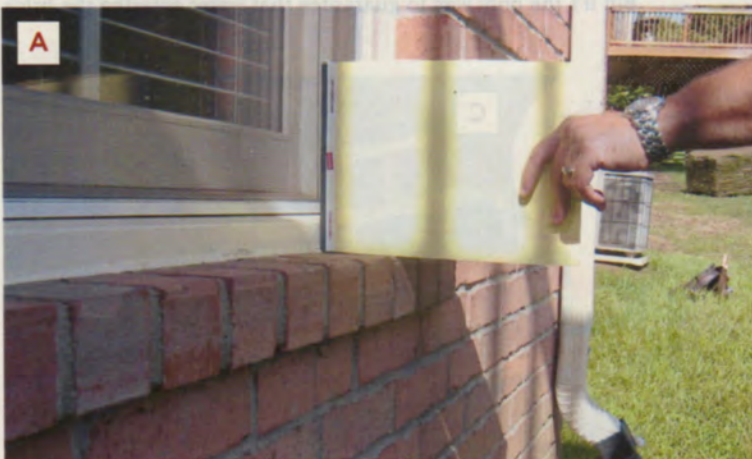
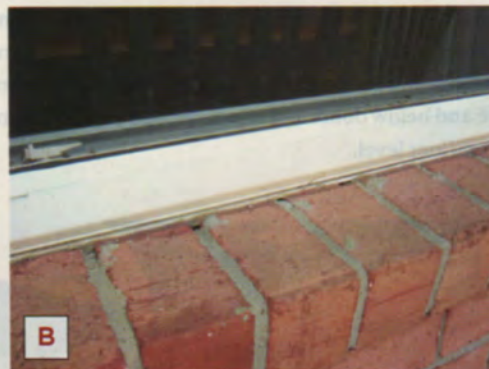
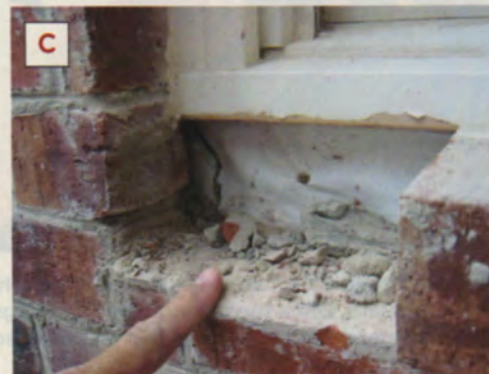
**Figure 5.** Unlike this one (A), window sills should be sloped 15 degrees. A close inspection reveals potential leak spots along this window frame (B); because there's no through-wall flashing, water will get into the framing. Instead of flashing below this window (C), there's a cavity clogged with mortar and compromised torn housewrap.

**Window sills.** Through-wall flashing should also be placed under the sloped course of brick (typically rowlock) immediately below the window. This is meant to catch any water that makes it into the wall cavity through or around the window. Sills should always be sloped at least 15 degrees, per BIA standards (Figure 5).

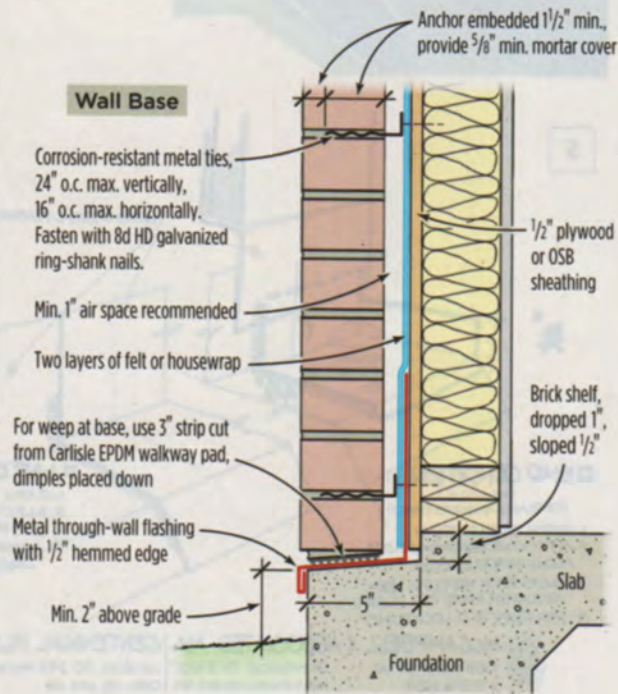
### Wall Base

**Above grade.** Too often, the bottom courses of brick are simply buried in the soil. There should be a through-wall flashing under the last course of brick above grade; this course must also be below the bottom of the first-floor framing. Flashing at this location serves two purposes: It prevents ground moisture from wicking up into the wall, and it catches any water coming from the cavity above and sends it outside.

Through-wall flashing should extend to the outer face of the brick. Anything short of that is that much less effective at getting the water out. And the back upper leg must be placed under the layers of building paper that protect the sheathing.

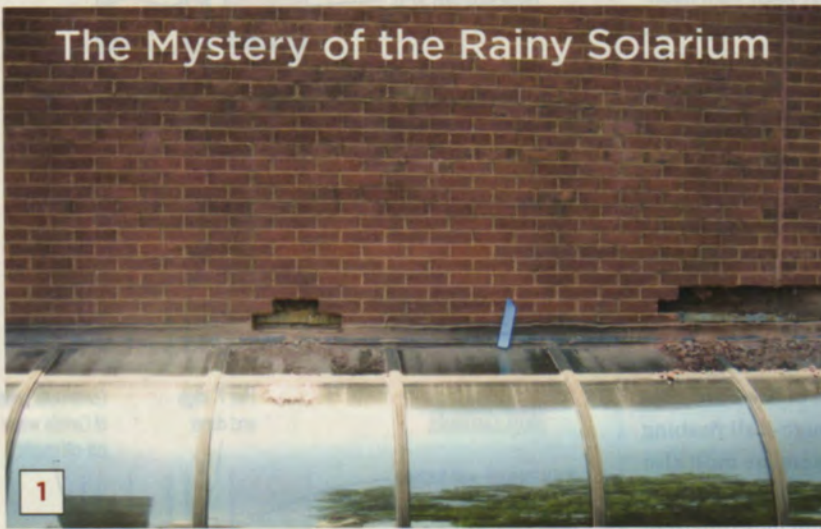
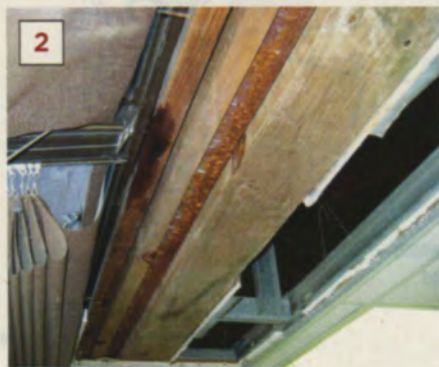
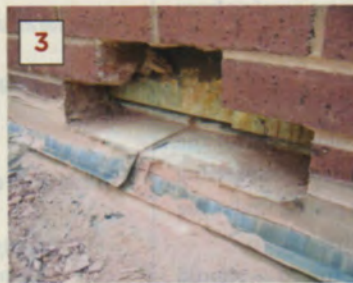
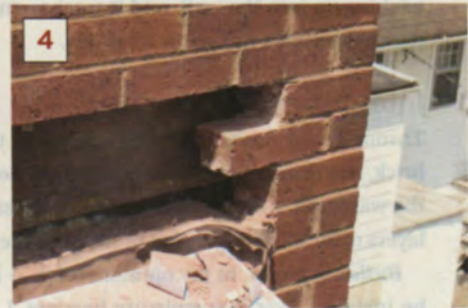
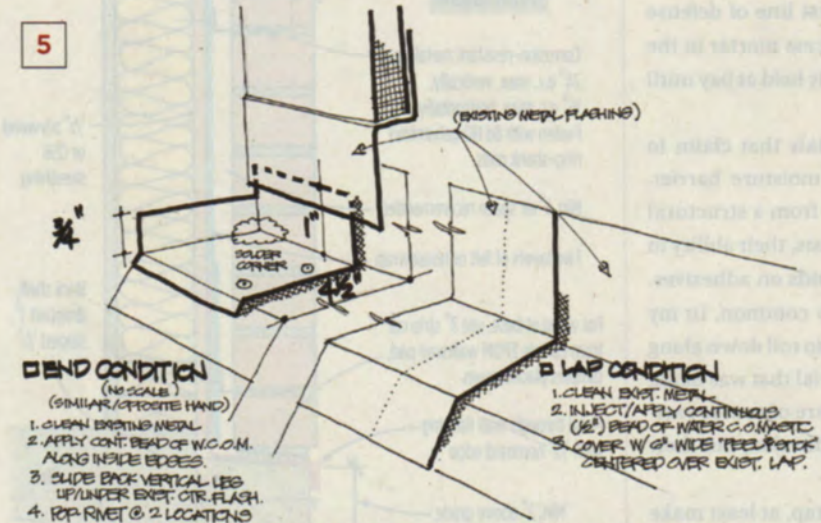
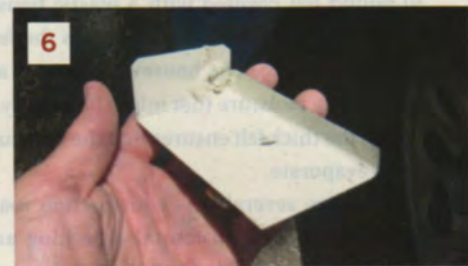
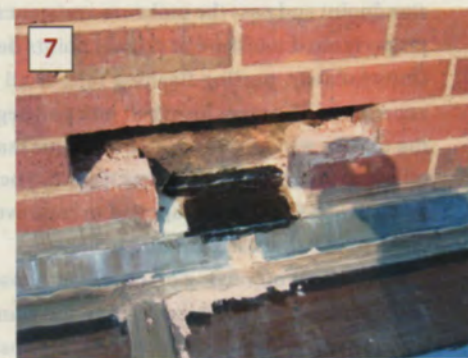
The offices under this curved glass roof (1) had been getting wet for years. The drops of water usually came down days after the rain — not surprising, given the height of the brick wall above, a likely water reservoir. I started with some controlled testing and discovered that water was showing up inside about 10 feet away from an area where I could see a lap in the metal through-wall flashing outside. Next I called for removal of the dry-wall ceiling (2) to further narrow the possible entry location. From what

I could see inside, I suspected that the laps in the flashing had failed, if they ever worked in the first place. We had no choice but to rent a bucket truck and — very carefully, considering the glass below — start deconstruction. We first uncovered the suspect lap joint, which — sure enough — was not sealed (3). I also pulled off the brick at the end of the solarium, pretty sure that I would find no end dam in the flashing there (4). Without dams, water would eventually make its way down into the walls at each end.

My recommended repair (5) called for all laps to be soldered and sealed, and for the installation of new end-dam flashings that would extend several inches past the glass roof. I made a mockup to show what I had in mind (6). When the roofing contractor did the repair, he soldered the new copper flashings wherever he could, and sealed them with Carlisle's Water Cut-Off Mastic, a clay-based caulk that effectively stops water as long as it's in compression and out of direct sunlight. For good measure, we also added a layer of uncured rubber membrane (7, 8). It's been years now and they've not had any leaks since.

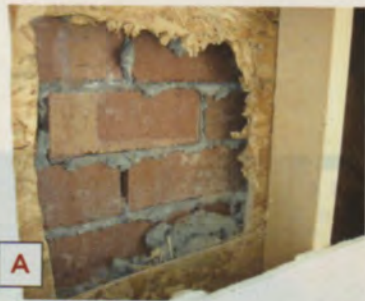
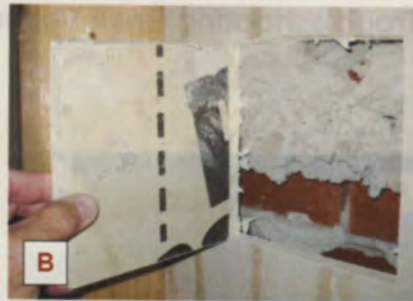
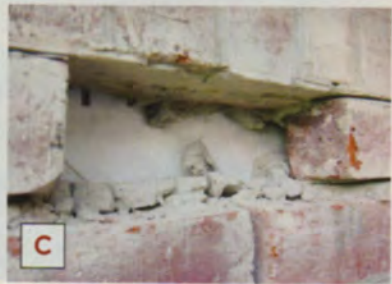
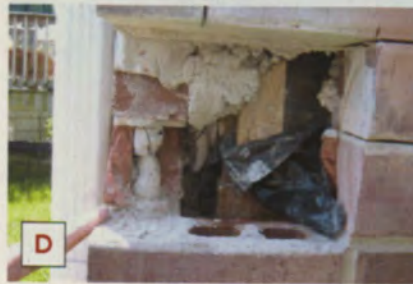
**Figure 6.** Destructive inspections from inside (A, B) and out (C, D) often reveal the cause of moisture, stains, and mold on interior finishes: The cavity is clogged with mortar, which holds water that eventually soaks the sheathing, framing, insulation, and drywall.

If wall cavities were created in a perfect world, they would be just that — cavities. The mortar, and any water it holds, would stay completely away from the felt or housewrap that guards the wall sheathing (Figure 6). But since masons are usually pressed to do their jobs as quickly as possible, excess mortar on the back

of the brick will naturally collect along the bottom of this cavity. As a precaution, always make sure that the back leg of the through-wall flashing at the base of the wall reaches above the likely level of the mortar droppings — 8 inches is good for a single-story house, more for additional stories.

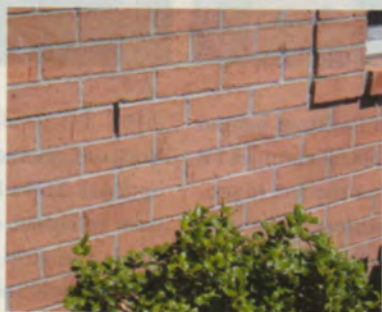
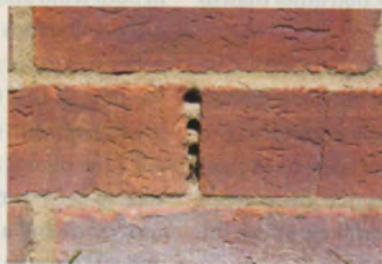
**Figure 7.** Randomly placed weeps (top) serve no purpose because there's no through-wall flashing to divert the water. Weeps drilled out after the brick is in place are a sure sign of missing flashing (above).

When inspecting leaky brick homes, I often note that there are no weep holes, or that they are in odd locations (Figure 7). Contractors, when pressed on the issue,

may insist that there are indeed through-wall flashings behind the brick, though at this point I have my doubts. Sometimes I'll find head joints that have been drilled out after the fact to provide weeps. In that case, even if there were flashings in the wall, there's a good chance that they would now have holes.

For through-wall flashings to work their best, there should be weep holes to allow the water out. The Brick Industry Association — my preferred source for details on the correct way to install brick veneer — recommends leaving an open head joint every 24 inches. The IRC allows for weep holes that are as small as  $\frac{3}{16}$ -inch in diameter, every 33 inches immediately above the flashing.

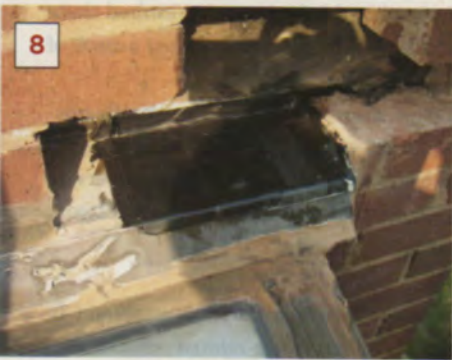
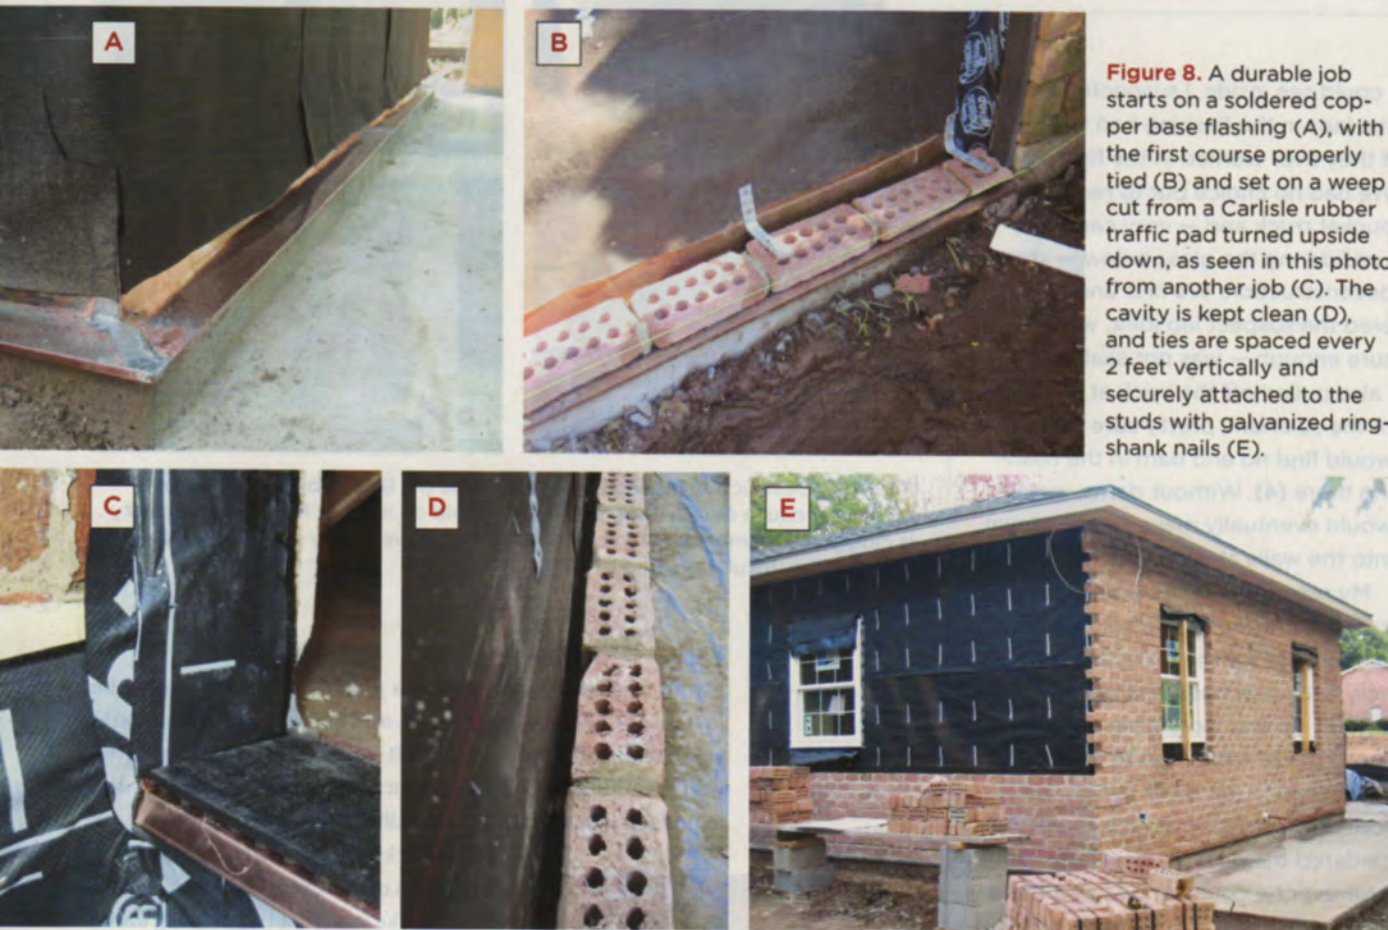
**Figure 8.** A durable job starts on a soldered copper base flashing (A), with the first course properly tied (B) and set on a weep cut from a Carlisle rubber traffic pad turned upside down, as seen in this photo from another job (C). The cavity is kept clean (D), and ties are spaced every 2 feet vertically and securely attached to the studs with galvanized ring-shank nails (E).

As the photos on this page show (Figure 8), it is actually possible to get a workmanlike brick veneer job, but it takes a mason who cares and a knowledgeable contractor willing to supervise and address the details. Given that combination, the brickwork should protect the structure indefinitely.
