### A Rot-Resistant Chimney Chase

by Mark Parlee

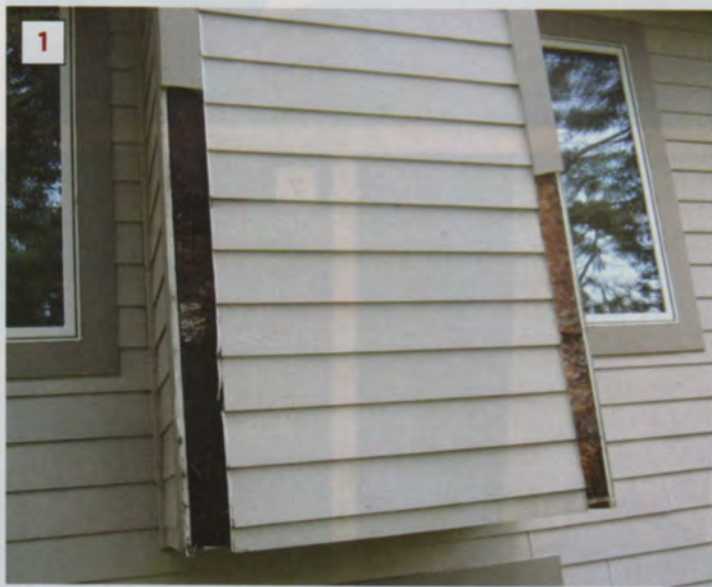
Framed chimney chases seem to be especially vulnerable, and I've repaired a lot of them over the years. For example, the house shown here was built just a few years before my crew and I began working on it, but already the paint was peeling from the fiber-cement clapboards, and the corner boards had begun to rot (1). When we dug a little deeper, we discovered deteriorated sheathing and rotted framing, too (2, 3).

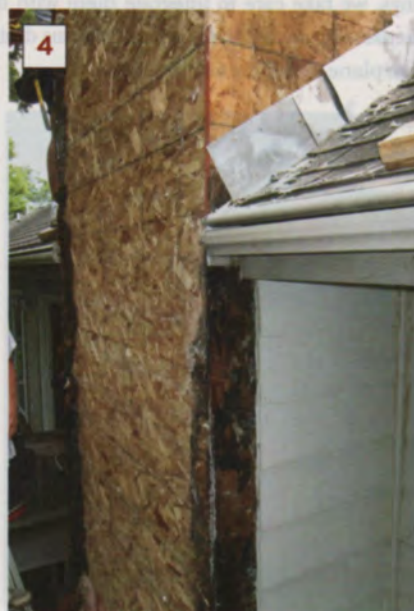
We found that most of the damage had been caused by water from the roof running behind the siding and down the sheathing — the result of some missing step flashings (4). Adding to the problem, the chase's OSB sheathing hadn't been covered with a water-resistive barrier. In an attempt to save a few hundred dollars, some builders omit housewrap over garages, chases, and gables in the mistaken belief that it's not required by code over unheated wall assemblies. In this case, a few extra flashings and some housewrap could have prevented thousands of dollars in damage.

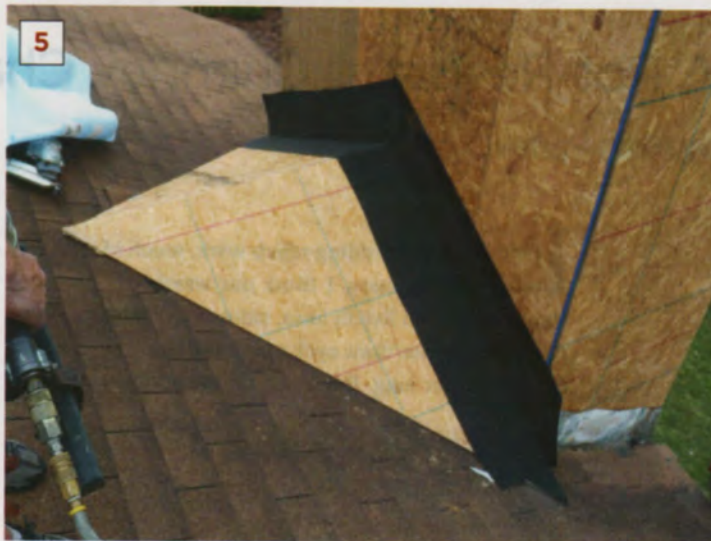
When we do a chase repair, we usually rebuild — or add — a water diverter, or cricket, at the top (5). We make the cricket wider than the chase by about 6 inches on each side. Extending the cricket past the corners helps divert water flowing down the roof away from the chase and also simplifies step-flashing installation.

Some builders omit the cricket altogether, and rely instead on a metal flashing at the roof-chase intersection — even when the chase is built on an eaves wall. But in my experience, the dam created by the metal flashing invariably fails. Crickets are more reliable, particularly in climates where snow can accumulate and lead to ice dams.

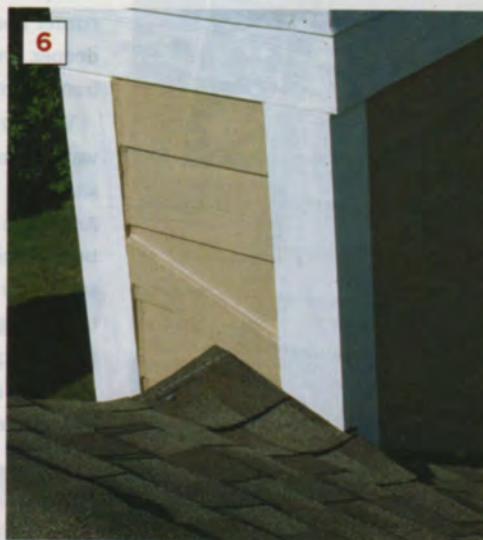
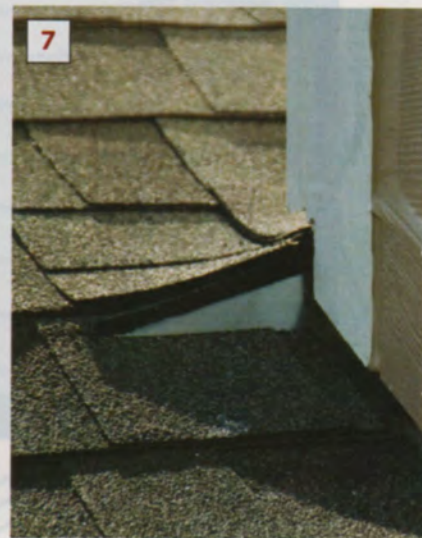
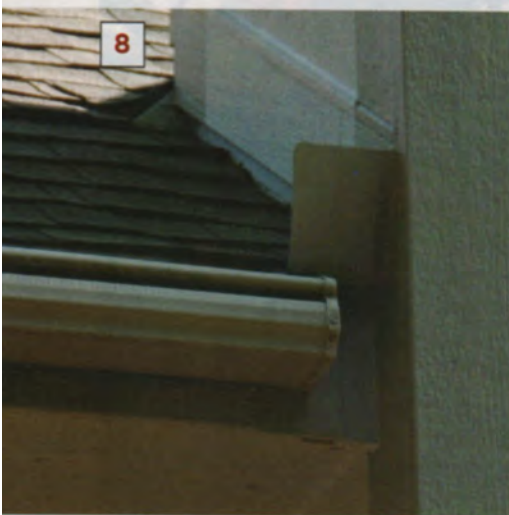
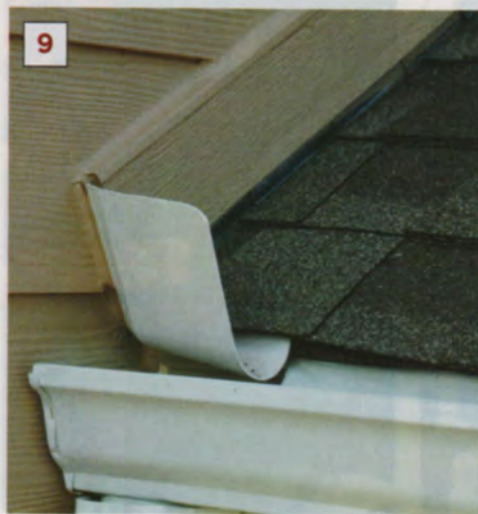
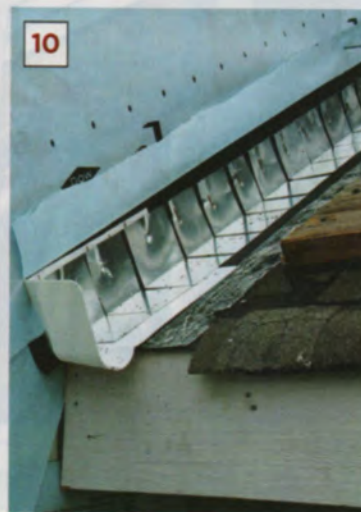
For chimney chases built into gable walls, we install a partial diverter (6), again extending the sloped surface several inches beyond the corner (7).

We always install diverter flashings whenever a roof intersects a wall; called “kickouts,” these keep water from running behind the cladding below and into the wall assembly (8, 9). Kickouts can be fabricated on site, but I like to use DryFlekt molded-plastic flashings (877/985-1010, dryflekt.com), which work well with various cladding materials. In the photos shown here, the water is diverted into gutters; but even without gutters, kickout flashings are very effective at protecting wall assemblies from water intrusion. As we install the flashings, we take care to integrate them with the housewrap so that there is a continuous drainage plane under the siding (10).

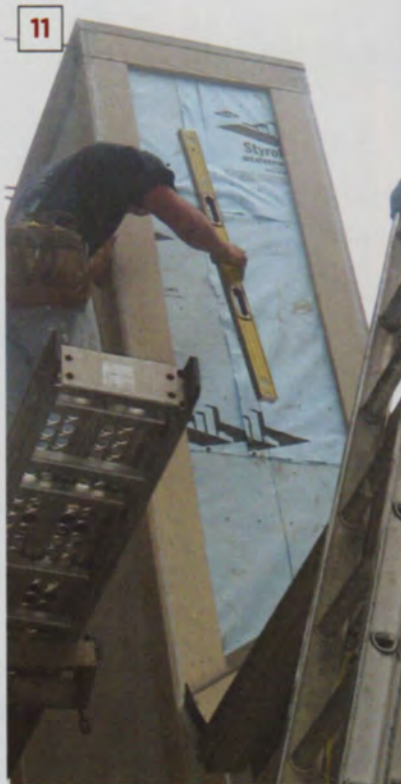
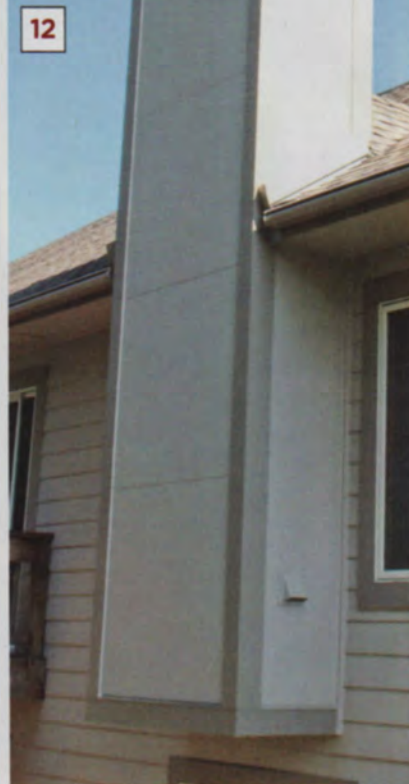
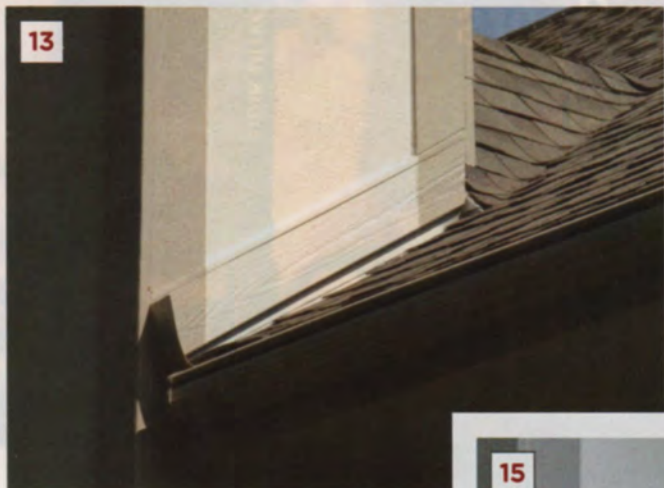
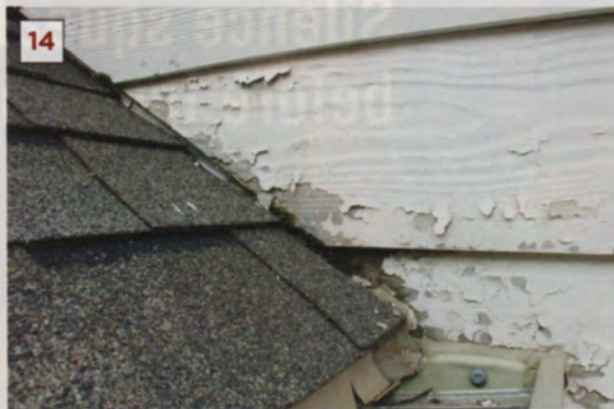
On this job, we wrapped the sheathing (11) before trimming out the chase corners with MiraTec treated composite trim, then replaced the original fiber-cement lap siding with  $\frac{5}{16}$ -inch-thick HardiePanel stucco-textured fiber-cement panels (12). I don't like the look of too much exposed step flashing, so we covered the steps with MiraTec trim installed at the pitch of the roof, maintaining an inch of clearance between the trim and the shingles (13). Some builders try to hide step flashings completely, but that's a bad idea, as this photo from another job shows (14).

We installed Z-flashing at most of the horizontal joints, and caulked the vertical joints with Flexible Seal elastomeric tripolymer sealant (562/946-8781, [flexibleseal.com](http://flexibleseal.com)). Where the HardiePanels butt against each other, we left a  $\frac{3}{16}$ -inch-wide gap between panels and sealed the gaps with beads of sealant.

We replaced the existing plastic vent hood for the fireplace's makeup air supply with a metal one, mounting it on a PVC block and cutting the siding panel around it (15). The block

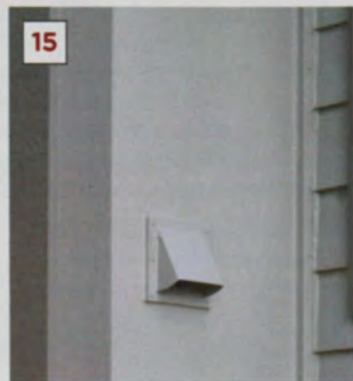
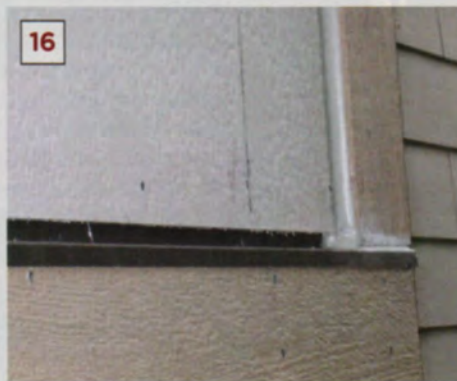
is sealed to the panel with sealant, but we left the joint between the bottom of the panels and the Z-flashing capping the trim at the chase base uncaulked, to allow any moisture that gets between the siding and the drainage plane to escape (16).
