# Basement Drainage Trench

by John J. Hare, AIA

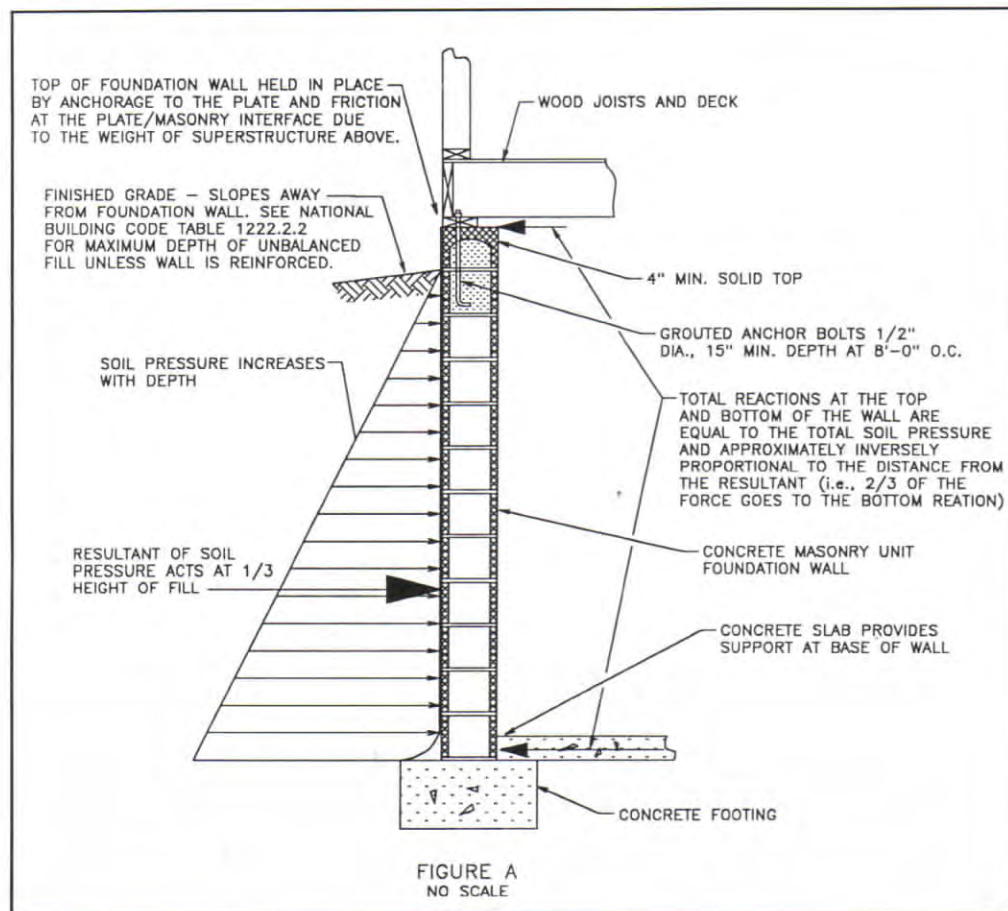
Basement foundation walls are generally designed as vertical beams supporting a horizontal load that increases with depth (see Figure A). In order for this beam to remain in place, it must have support at both ends. This support is provided: at the top (by the attachment of the plate and joists to the top of the foundation wall); and at the bottom (by the basement slab which abuts the foundation wall). If one looks at the pressure distribution of the loading diagram, it is easy to see that most of the load reaction goes to the bottom of the wall. If the slab does not abut the foundation wall to restrain movement, the only restraint provided to prevent the foundation wall from sliding on the footing is the mortar bond between the concrete footing and the foundation wall.

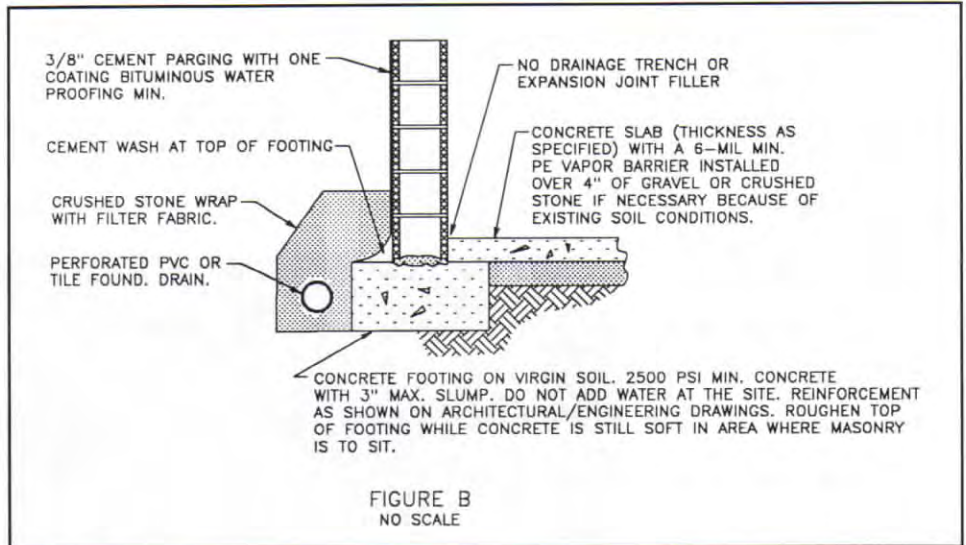
As such, the need for such a trench is highly questionable. Given that the cost of either of the solutions shown in Figures C and D, along with the cost of installing the trench, would far outweigh the additional cost necessary to build a properly dampproofed and backfilled masonry foundation wall, the better solution to the problem would be proper workmanship in dampproofing and backfilling. This being the case, the bottom of the foundation wall can be constructed as normally done and as shown in Figure B.

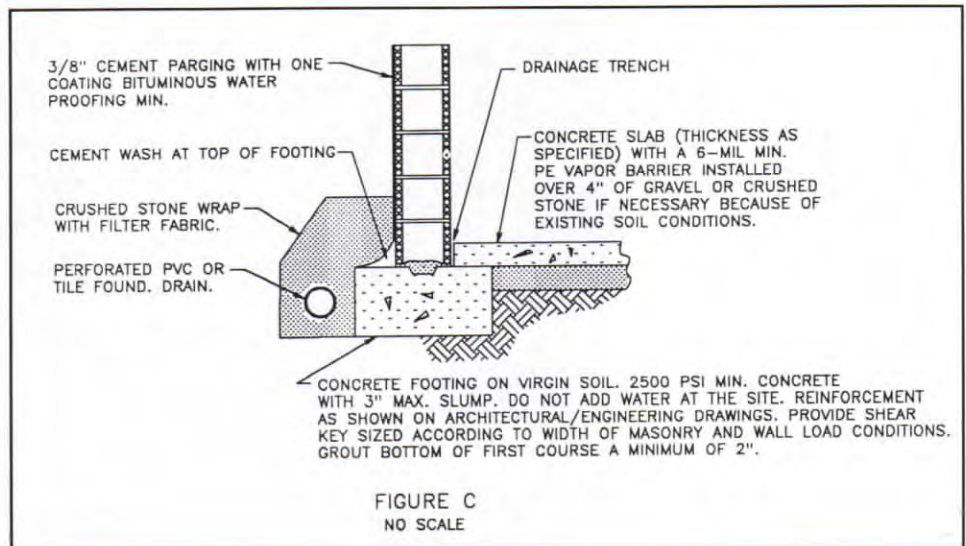
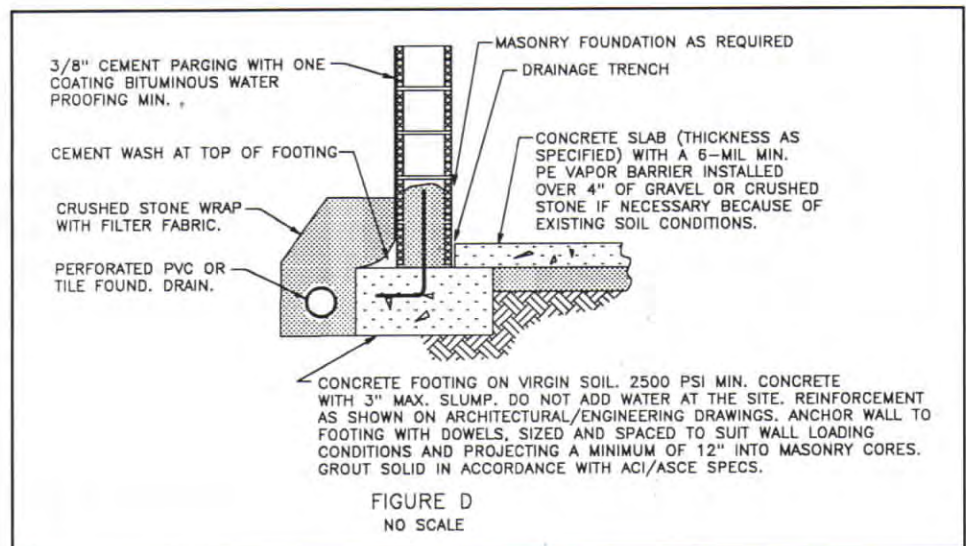
first course of masonry, one can hardly expect any bond to exist between the footing and the foundation wall. Consequently, unless special provisions, such as dowels from the footing into the masonry or shear keys, are provided, the foundation wall will, as the soil compacts, develop a mortar shear failure at the base of the wall. The foundation wall will then slide on the footing until it comes into contact with the slab. Since the drainage trench is usually 1 inch to 1½ inches wide or more, it is highly likely that this excessive amount of movement will completely shatter a concrete block masonry foundation wall. Under these conditions, the trench, which was originally installed with good intentions, is the cause of an excessively cracked wall creating the potential for even more disastrous consequences; i.e., complete foundation failure. In order to prevent this sliding of the foundation wall on the footing, if the builder insists on installing the trench at the slab edge, the builder should be required to install a shear key in the footing, or if loads require, to install vertical reinforcing from the footing into the wall cores then grout them solid (see Figures C and D).
