## UPDATE

## EXTERIOR INSULATION & FINISH SYSTEMS (EIFS) LEAD TO WOOD DAMAGE & INFESTATION

## **AN INTRODUCTION TO EXTERIOR INSULATION AND FINISH SYSTEMS (EIFS)**

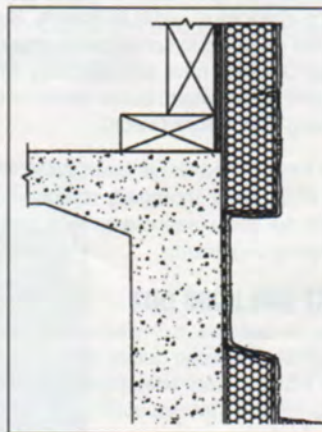
*Detail shows termite detection port and not acceptable to NPCA and code officials in very heavy termite infestation areas.*

4. Do not use a liquid termiticide if the EIFS construction extends into the soil. The foam insulation used with EIFS is rigid foam board and is untreatable if below grade. Below grade installation is prohibited for new construction by code in many areas of very heavy termite infestation; however, many houses were built with the material below grade before the code change.

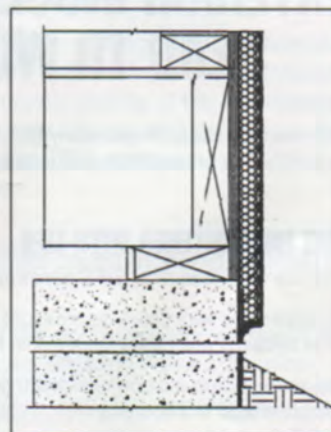
*Detail showing gap above grade*

EIFS manufacturers have taken steps to reduce the chances of water infiltration and infestation. First, manufacturers are looking at materials and testing new methods that will reduce chances of water infiltration. Second, the application specifications are more detailed including in some cases channels to divert water out of the wall once infiltrated. Design changes have provided only limited success. Third, most manufacturers now call for EIFS not to extend below grade or less than eight inches above grade (see Detail Showing Gap Above Grade).

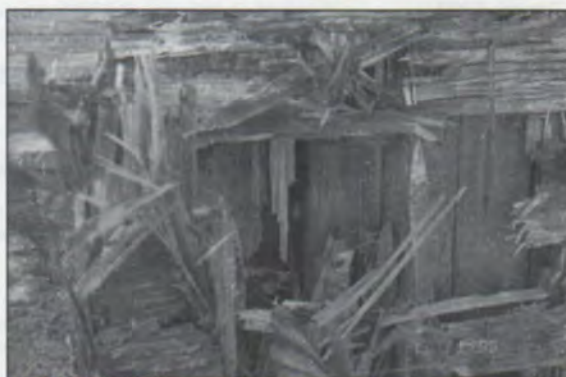
*A PCO's nightmare: Wood damage beneath a window in an EIFS building.*

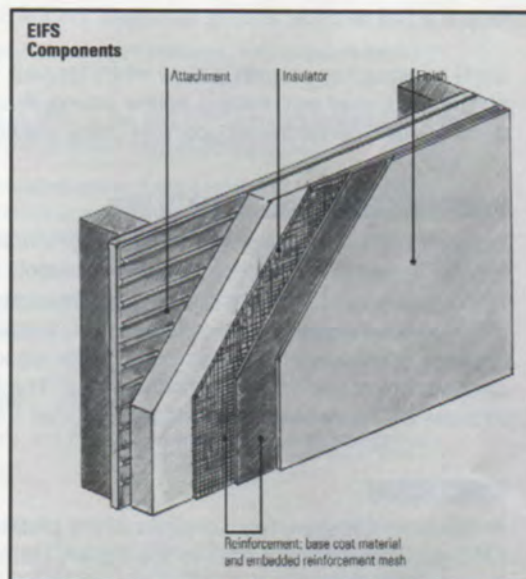
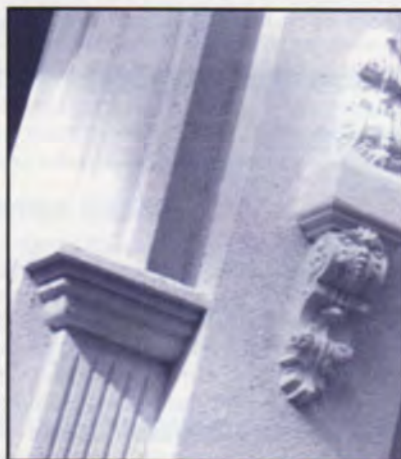
*EIFS Building Detail*

The EIFS construction includes the following:

- Substrate such as plywood attached to the wall studs
- Insulation board
- Reinforcing mesh
- Base coat of finish
- Acrylic copolymer or equivalent finish coat

Keep in mind that all of these materials are on the outside of the structure. For this reason, the manufacturers of the EIFS advertise the system as being energy efficient. The building is essentially clad in insulation with tight seals around windows and doors. Traditional insulation fits between the studs on the inside of the building and is subject to air infiltration. EIFS in theory reduce the air infiltration. According to the EIFS Industry Members Association (EIMA), EIFS can eliminate up to 55% of the air infiltration as compared to brick or wood construction.
