Manufactured-Stone Nightmares

by Dennis McCoy

Without proper flashing, heavy-duty building paper, and weep holes, walls behind cast-stone veneer can get wet

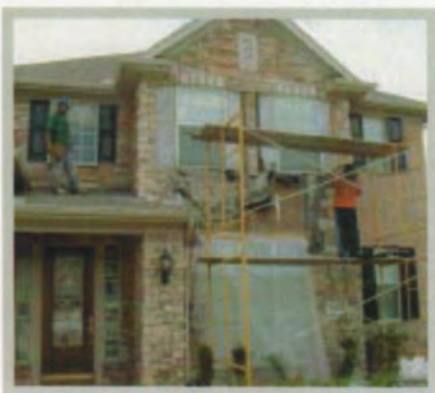
leaks and rot often show up sooner, progress more quickly, and cause more severe damage inside the wall (see Figure 1).

Figure 1. Where stucco (top photos) and cast stone (bottom) have been installed on the same home, the author frequently finds more severe moisture and rot damage under the cast-stone portions of the exterior. One reason is that the stucco terminates at the bottom with a weep screed, while the cast stone sits in a bed of mortar and grout, directly on a foundation ledge, with no weeps or flashings.
