HANDLING COMPLAINTS TROUBLE SHOOTING

HARDWOOD FLOORING

A Guide to Identifying and Correcting Common Job-Site Hardwood Flooring Problems.

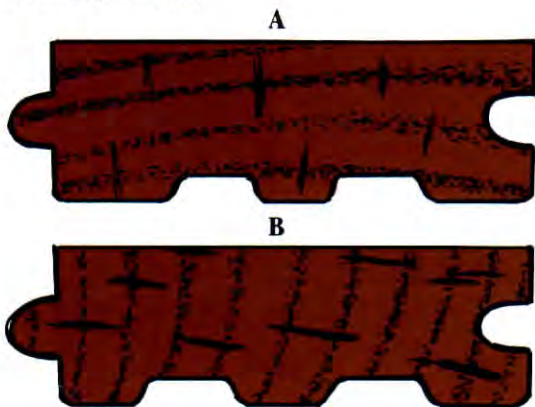
Fig. 2. (A) Plain-sawn boards have grain (the tree's growth rings) flat with the board. Slight curves make wide boards cup slightly. (B) Quarter-sawn boards have grain vertical to the board's wide dimension. Expansion follows the grain direction about 4-1, making quartered boards more stable.

NORMAL CUPPING. Some cupping should be considered normal, especially in wide planks -- 5, 6, 7" and wider -- and particularly in plain-sawn boards. In such boards (as opposed to quarter-sawn; see Fig. 2) the growth rings of the tree travel in a slightly curved pattern from one side of the board to the other. This curved pattern produces, with normal moisture content changes, a slight convex or concave cup, depending on how the rings curve within individual boards.

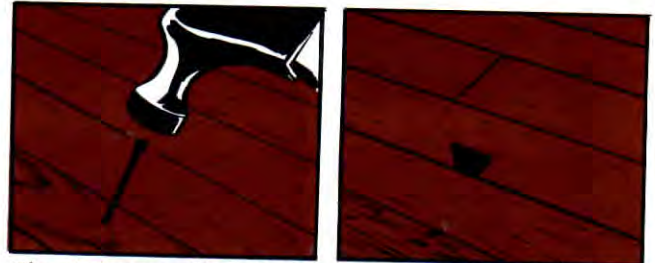
Fig. 3 Face-nailing flooring to remove squeaks and looseness should be at an angle and into a joist or screed. Pre-drilling saves many bent nails.

Fig. 4 Glazing points driven between boards into the tongue of strip can be used as a wedge to stop squeaks in floors.

Dip wood wedges in carpenter glue and gently drive them between the joists and subfloor (or fasten them in place with brads). Don't use wedges to separate the subfloor from joists. Another source of squeaks is in the flooring itself. A slightly loose tongue-and-groove match, with less than adequate nailing, or a void under the squeaky area, can allow the flooring boards to rub together.

SOLUTION: If the movement is not enough to see, the best correction may be wood floor wax (paste wax is ideal) worked between the offending boards. If they are too tight this lubricant may not penetrate. Graphite or penetrating oil sprayed on the surface may also work; or dusting with talcum or baby powder can also lubricate the squeak. (If the floor finish is a seal-and-wax type, oil or graphite may discolor the surface.) Where a minute crack is visible between boards, the squeak may originate with the nails holding the flooring to the subfloor. If one or more are loose, face-nailing may be the only answer. Drive nails at an angle (Fig. 3) into the open grain of the wood, as they are far easier to hide here. Another solution is to drive triangular glazing points into cracks between boards to wedge them tight enough to prevent squeaks (Fig. 4). Still another method is to drill a small hole in the crack between boards and squirt carpenter glue in the hole. Fill the hole with a putty stick.

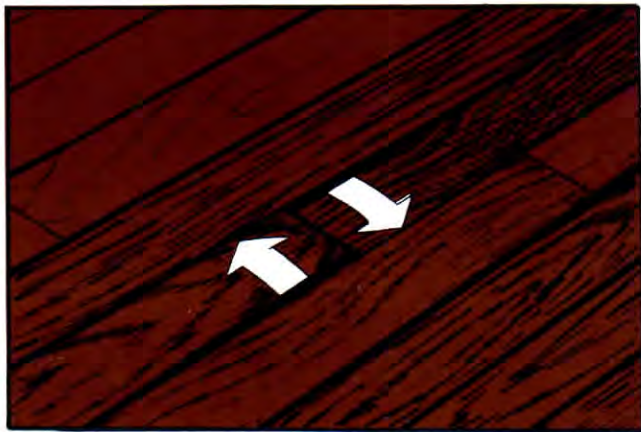
Fig. 5. Cross-pull results when two strips are pulled in opposite directions because of being nailed to different subfloor boards.

Cross-pull. This is manifested in flooring strips as planks moving in opposite directions at end joints. In other words, two strips which abut at the end are pulled in opposite directions because one is nailed to a different subfloor board from the other. If the two subfloor boards shrink in opposite directions, cross-pull results, with a crack down the left side of one strip, switching to the right side of the other at the end joint (Fig. 5).
