# A New Way of Attacking Mold in Attics

By Michael A. Pinto, CSP, CMP

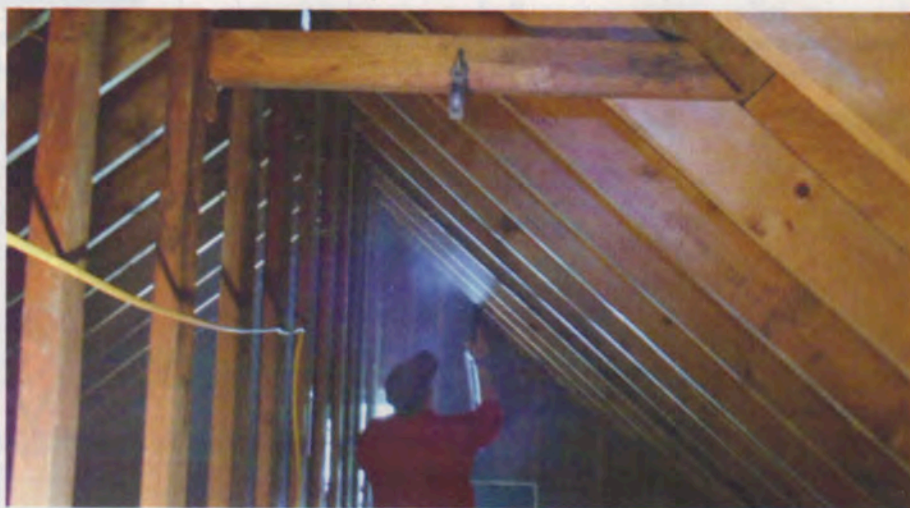
Sampling, using four separate methods, recorded the effectiveness before, during and after the work was conducted. Both surface and air sampling were conducted in the attics. Air samples were also collect-

ed in the occupied area of the home, and outdoor air samples were taken to confirm ambient conditions. Surfaces were tested with both adenosine triphosphate (ATP) technology, which measures biological residue, and the collection of actual surface materials. Direct samples of the surfaces were collected from the wooden studs and roof decking using a "microvacuum" technique and also Bio-Tape sample collection devices. There, direct samples were subjected to visual microscopy, as were the air samples.

fungal concentrations. All the surface sampling methods (ATP, microvacuum and Bio-Tape) showed significant reductions from the pre-work samples to the post-fogging evaluation. The ATP results were tabularized as noted in the above table.
