REPAIRING ALUMINUM WIRING

U.S. Consumer Product Safety Commission
Bethesda, MD
www.cpsc.gov
www.SaferProducts.gov

Publication 516

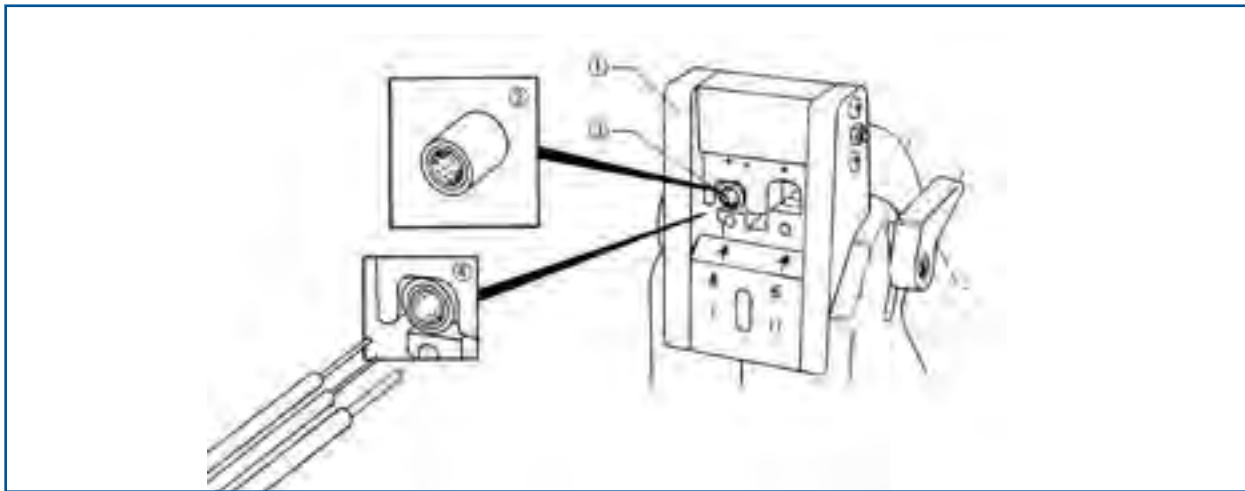
The COPALUM connector is a specially designed system that includes a metal sleeve intended to be installed only with a dedicated power tool and crimping die to make a permanent connection, that is, in effect, a cold weld (the precision dies in the COPALUM tool compress the connector and wires using upwards of 10,000 pounds of force, as required to make the permanent aluminum wire connection).

COPALUM Crimp Connector and its Specialized Installation Tooling

The tool is shown in the illustration below. An insulating sleeve is placed around the crimp connector to complete the repair. The copper wire pigtail is then connected to the switch, receptacle, or other termination device. An example of a repaired receptacle outlet is also illustrated below.

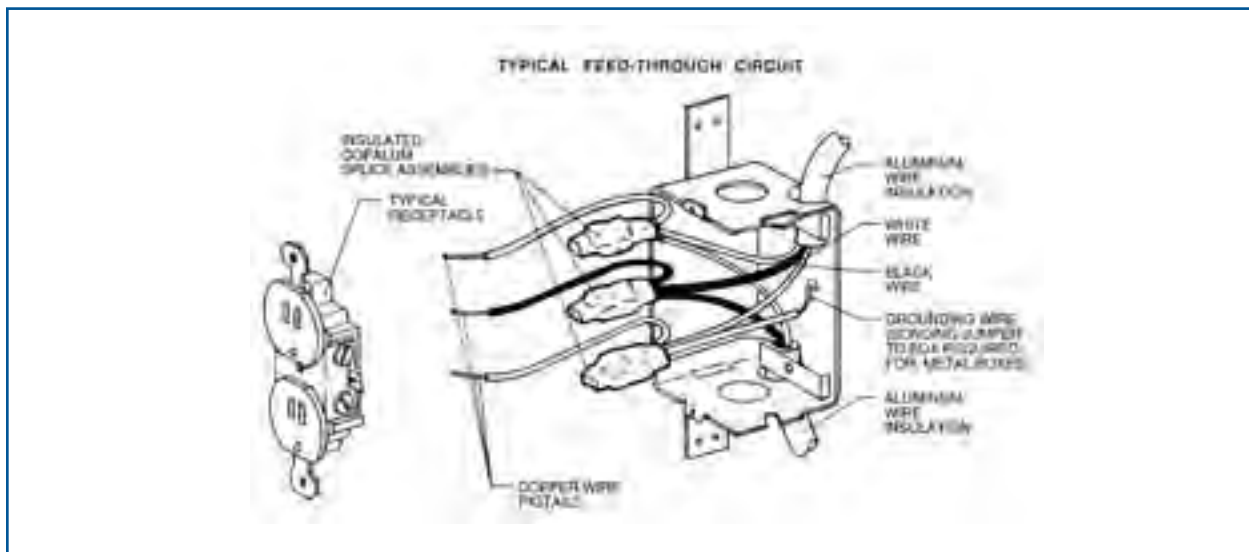
Recommended COPALUM Connector Repair

As an alternate to rewiring with copper, CPSC recommends attaching a short section of copper wire to the ends of the aluminum wire at connection points (a technique commonly referred to as “pig-tailing”), using a special connector named COPALUM to join the wires. CPSC staff considers pig-tailing with a COPALUM connector to be a safe and permanent repair of the existing aluminum wiring. The repair should include every connection or splice involving aluminum wire in the home, including outlets, dimmers, switches, fixtures, appliances, and junction boxes. The repaired system, with short copper wire extensions at every termination throughout the home, permits the use of standard wiring devices, including receptacles and switches.

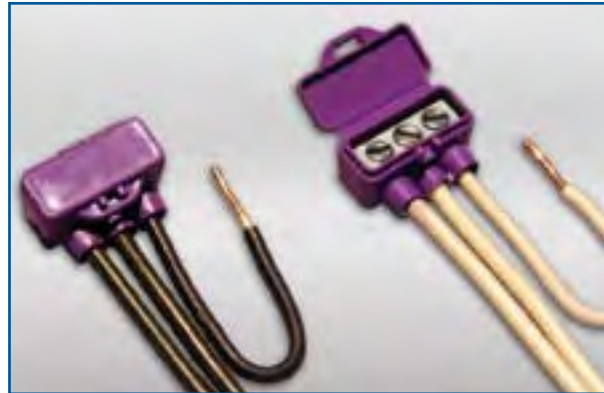
CPSC staff recognizes that copper replacement may be cost prohibitive and that the COPALUM repair may be unavailable in a locality. Based upon an evaluation that was, in part, CPSC supported,⁵ consumers are advised that, if the COPALUM repair is not available, the AlumiConn connector may be considered the next best alternative for a permanent repair. This repair method involves pigtailing using a setscrew type connector instead of the COPALUM crimp connector in the repaired connections. The AlumiConn connector has performed well in initial tests, but is too new to have developed a significant long-term safe performance history as the COPALUM repair. The repair should be conducted by a qualified electrician because careful, professional workmanship and thoroughness are required to make the AlumiConn connector repair safe and permanent.

The AlumiConn Connector

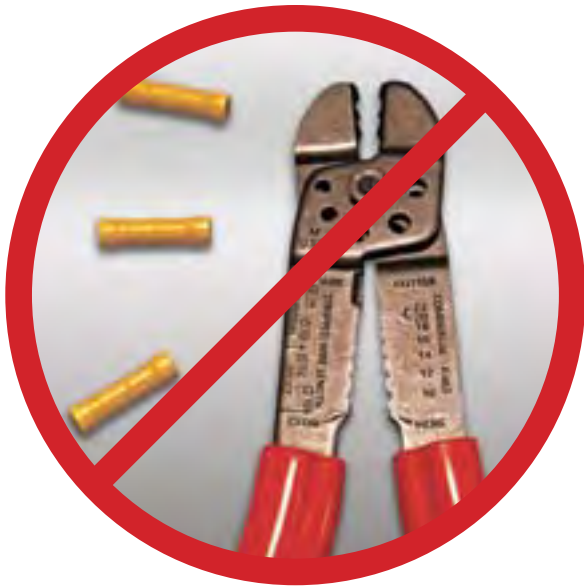
There are many other brands and types of crimp connectors – including those intended to be installed with a pliers-type of handtool – which are readily available to consumers at common retailers.

No other crimp connectors have been evaluated for connecting copper and aluminum conductors. CPSC staff strongly recommends against their use as a repair method.

Do Not Use Common Hand-Crimped Connectors with Aluminum Wire

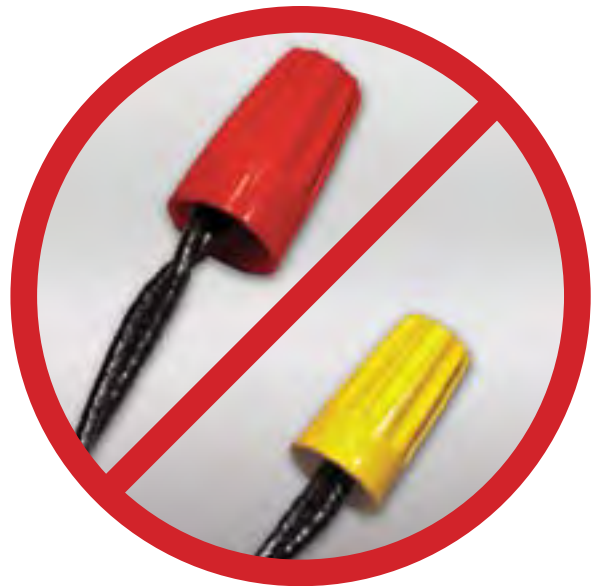
The first temporary repair involves pigtail with a twist-on connector. The effectiveness of “pigtail” using twist-on connectors has been evaluated by CPSC staff. In CPSC-sponsored laboratory testing and life tests, substantial numbers of these connectors overheated severely.

of twist-on connectors with aluminum wire. It is possible that some pigtail “repairs” made with twist-on connectors may be prone to even more failures than the original aluminum wire connectors. Accordingly, CPSC staff believes that this method of repair does not solve the problem of overheating present in aluminum-wired branch circuits.

“Pigtail” with Twist-on Connectors Is Not a Recommended Repair
